# Burgoyne

Our Ref: 713807/CLG

27 October 2023

**INSURED: ANDREAS INVESTMENTS LTD**  
**INCIDENT: BUILDING COLLAPSE AT 68A HAROLD STREET, GRIMSBY, DN32 7NQ**  
**INCIDENT DATE: 13 SEPTEMBER 2023**

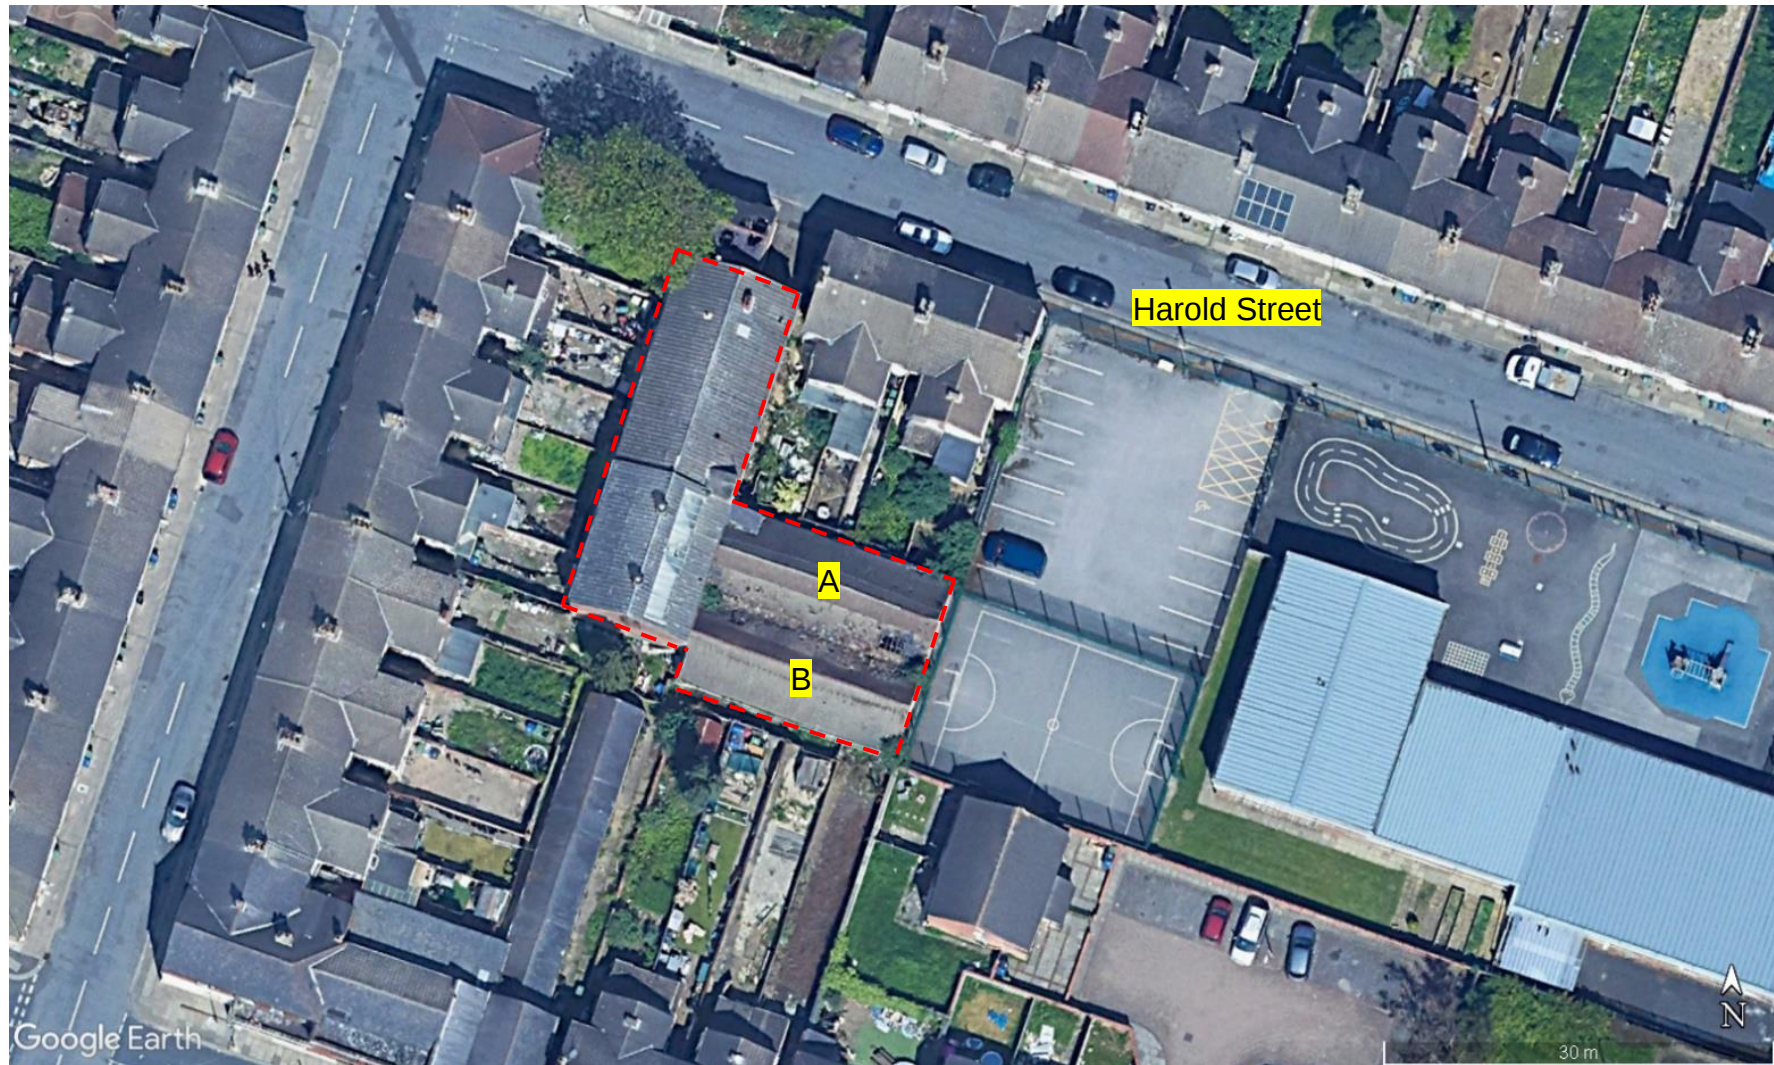
Figure 1 is a Google Earth image (dated April 2023) showing the location of the incident address relevant to neighbouring properties. It is an L-shaped industrial building (highlighted in red), with a main two-storey section, aligned north-south, accessible from Harold Street to the north, and a single-storey section, aligned east-west, attached at the south-east end. This part of the building was of traditional brick construction with a twin-pitched, timber-framed, tiled roof. For the purposes of this report, I have denoted the single-storey section as the “extension”, and its north and south roof pitches as A and B, respectively. The south elevation of the extension (highlighted in yellow in Figure 2) faced the back gardens of four properties on Castle Street to the south. The east gable walls of the extension were adjacent to a school playground.

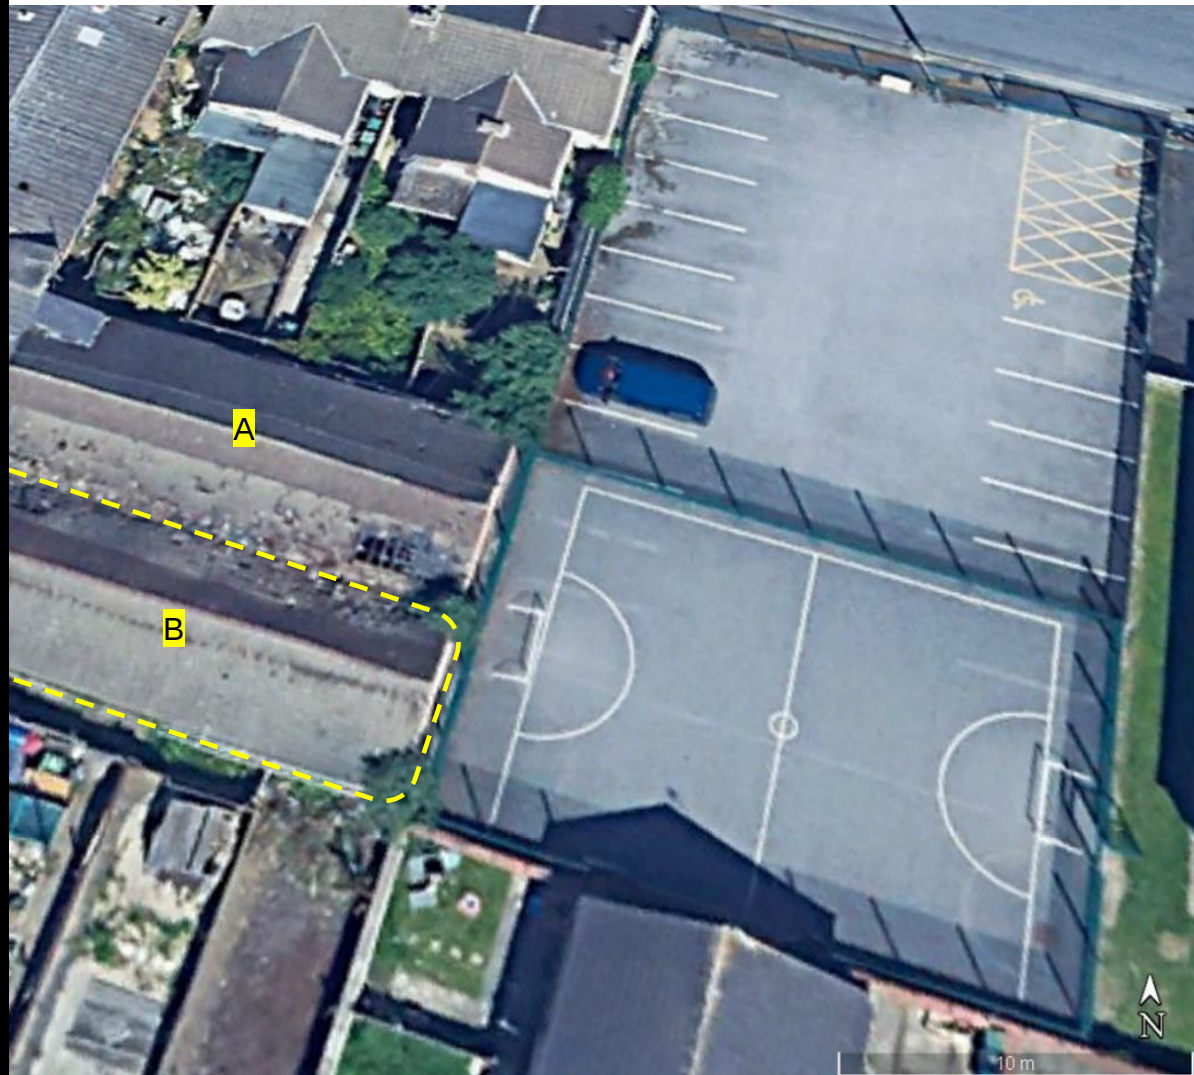
**Figure 2**

Figure 2 is a closer aerial view of the extension, showing damage to roof A, where tiles were missing/dislodged and there was a substantial hole at the east end, adjacent to roof B. I have appended an historical aerial image, which shows similar damage to the roof in September 2019 (Figure 3).

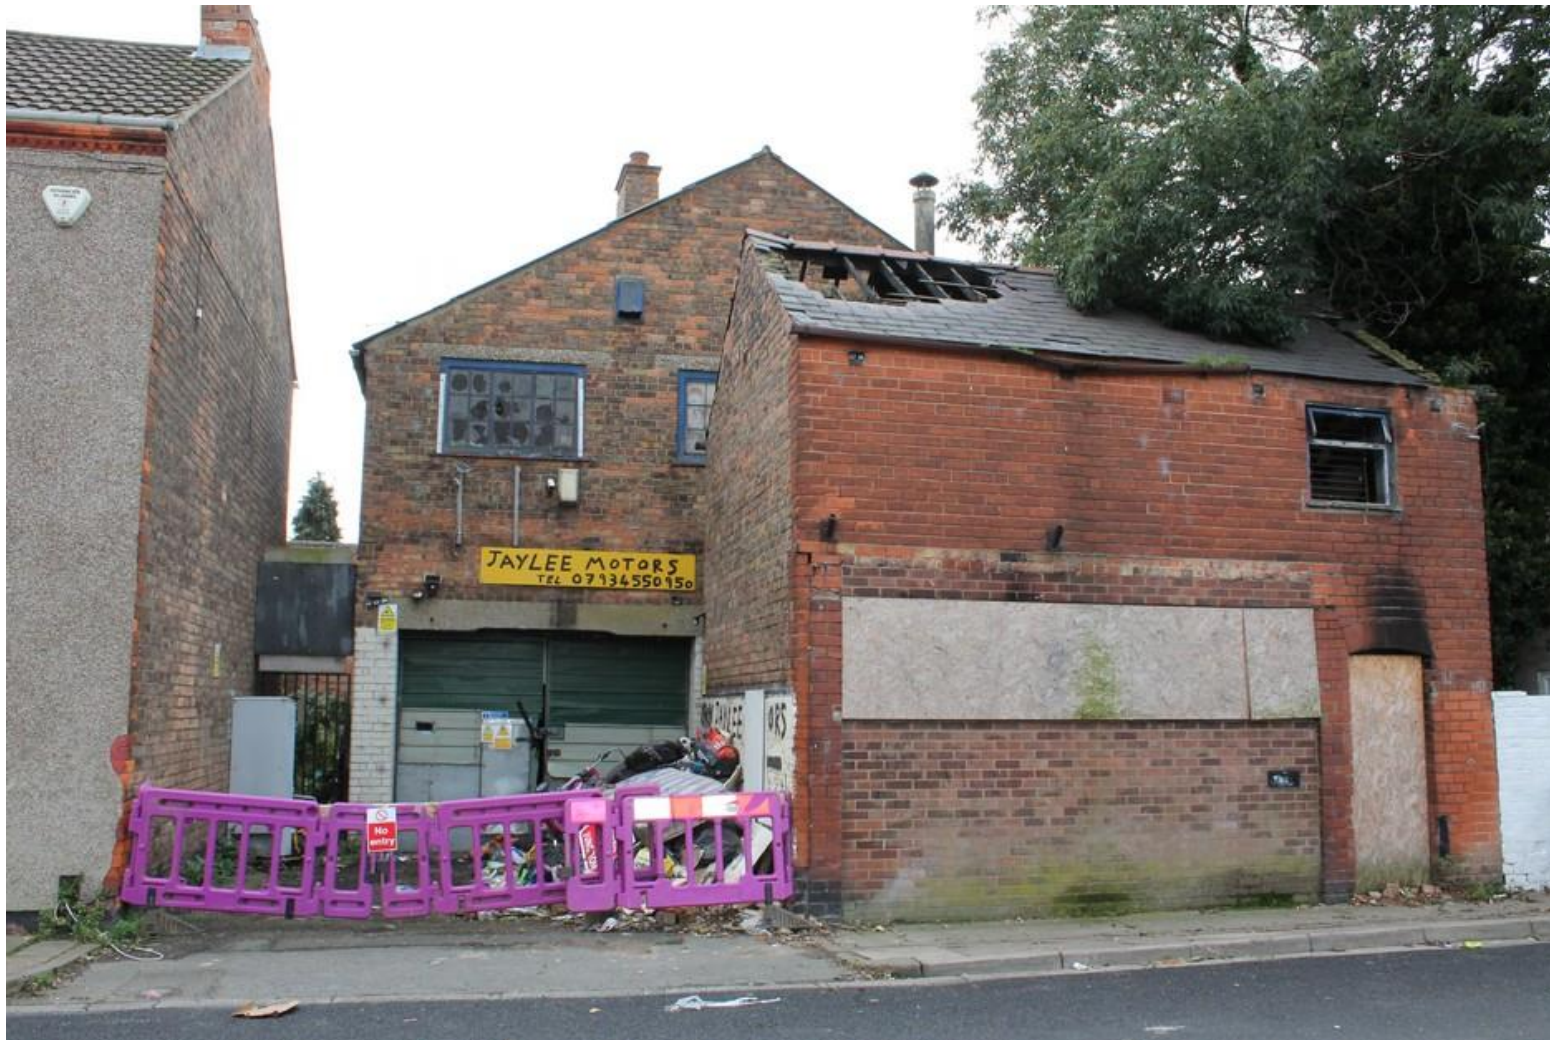
**Photograph 1**

Photograph 1 is a view from Harold Street towards the front of the loss address. A separate building, which I understand was part of the premises, had evidently suffered a previous fire.

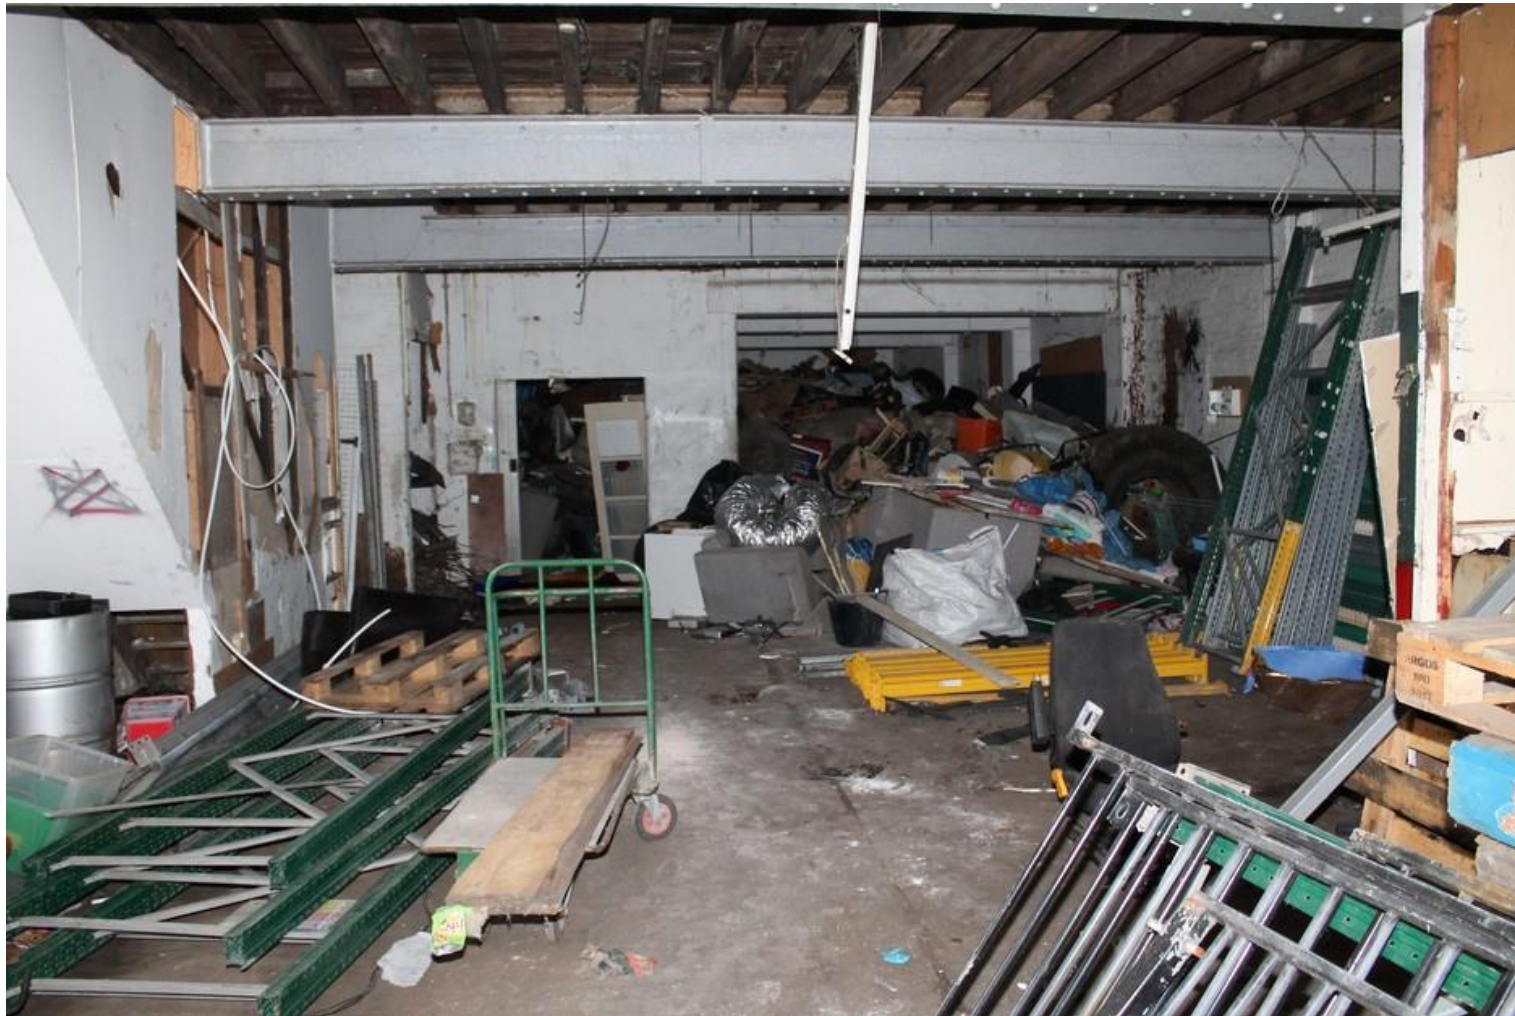
**Photograph 2**

Photograph 2 is a view from the front entrance into the ground floor area of the main building. The mains electrical supply entered the property at the front, but the supply equipment downstream of the service head was missing, i.e. there was no mains electrical supply to the fixed wiring in the building. I saw no indication that the property was connected to a mains gas supply; I did not find a gas meter or any gas appliances such as a boiler. The rear part of the ground floor was essentially filled with a large pile of what appeared to be general waste, including car parts, tyres and assorted items (Photograph 3), and this area was not accessible.

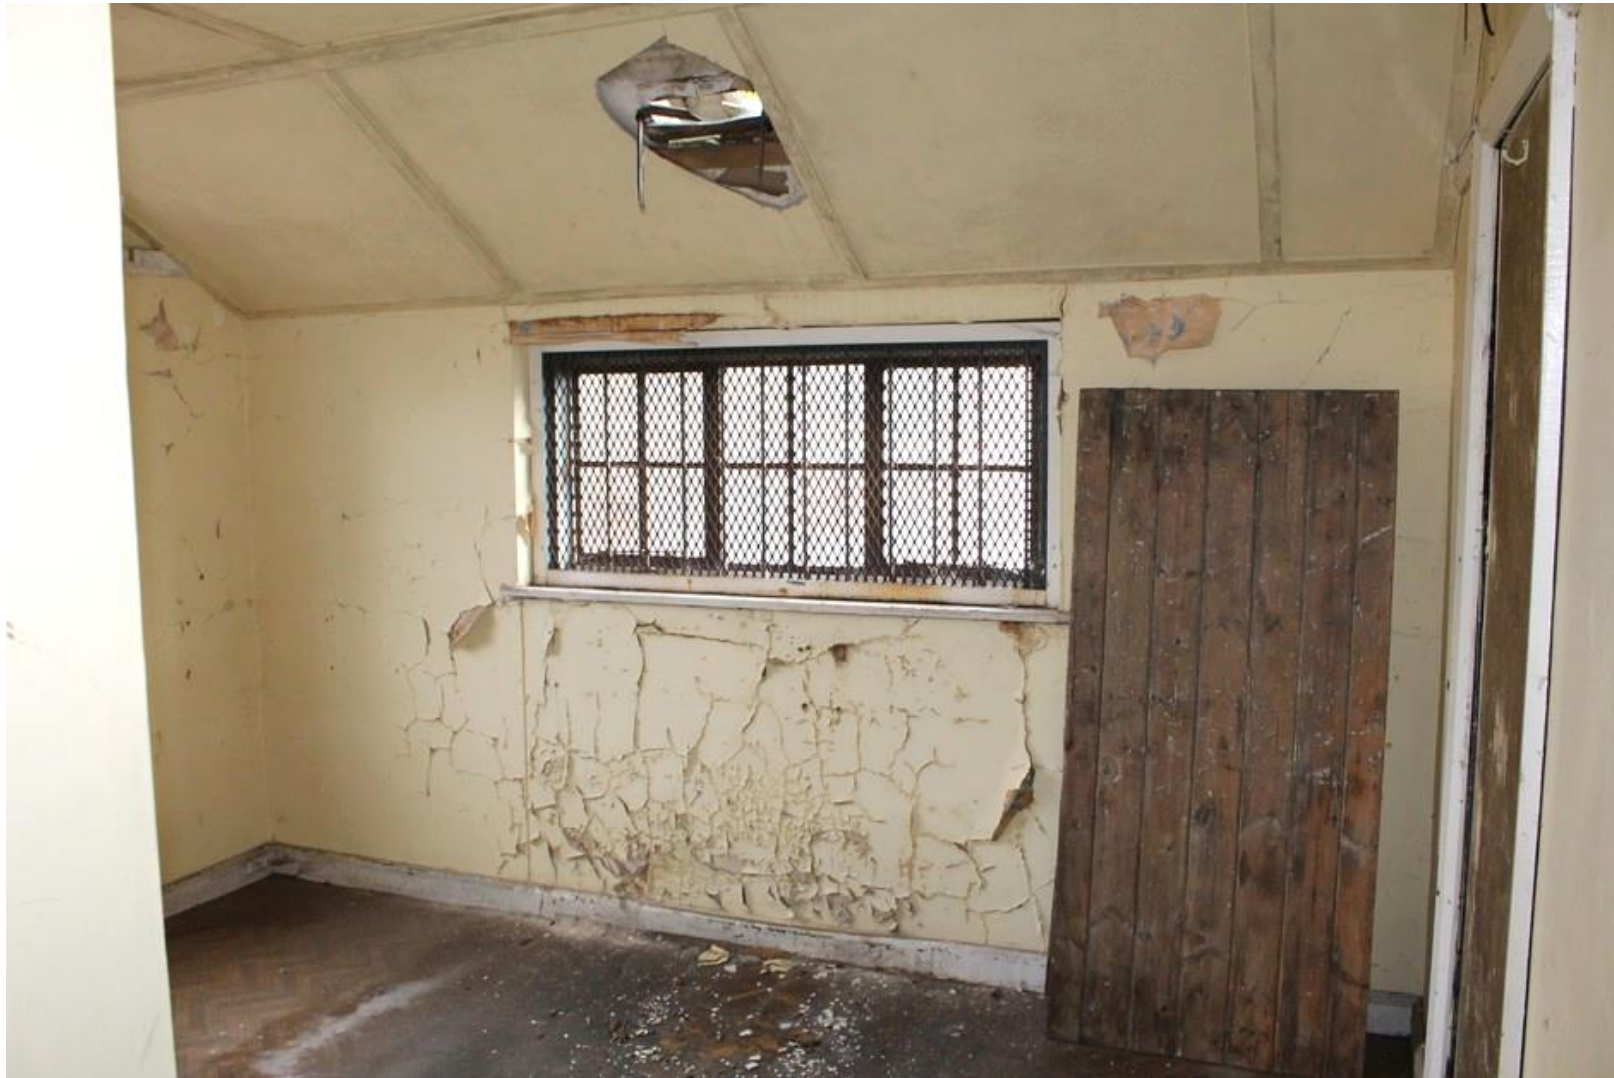
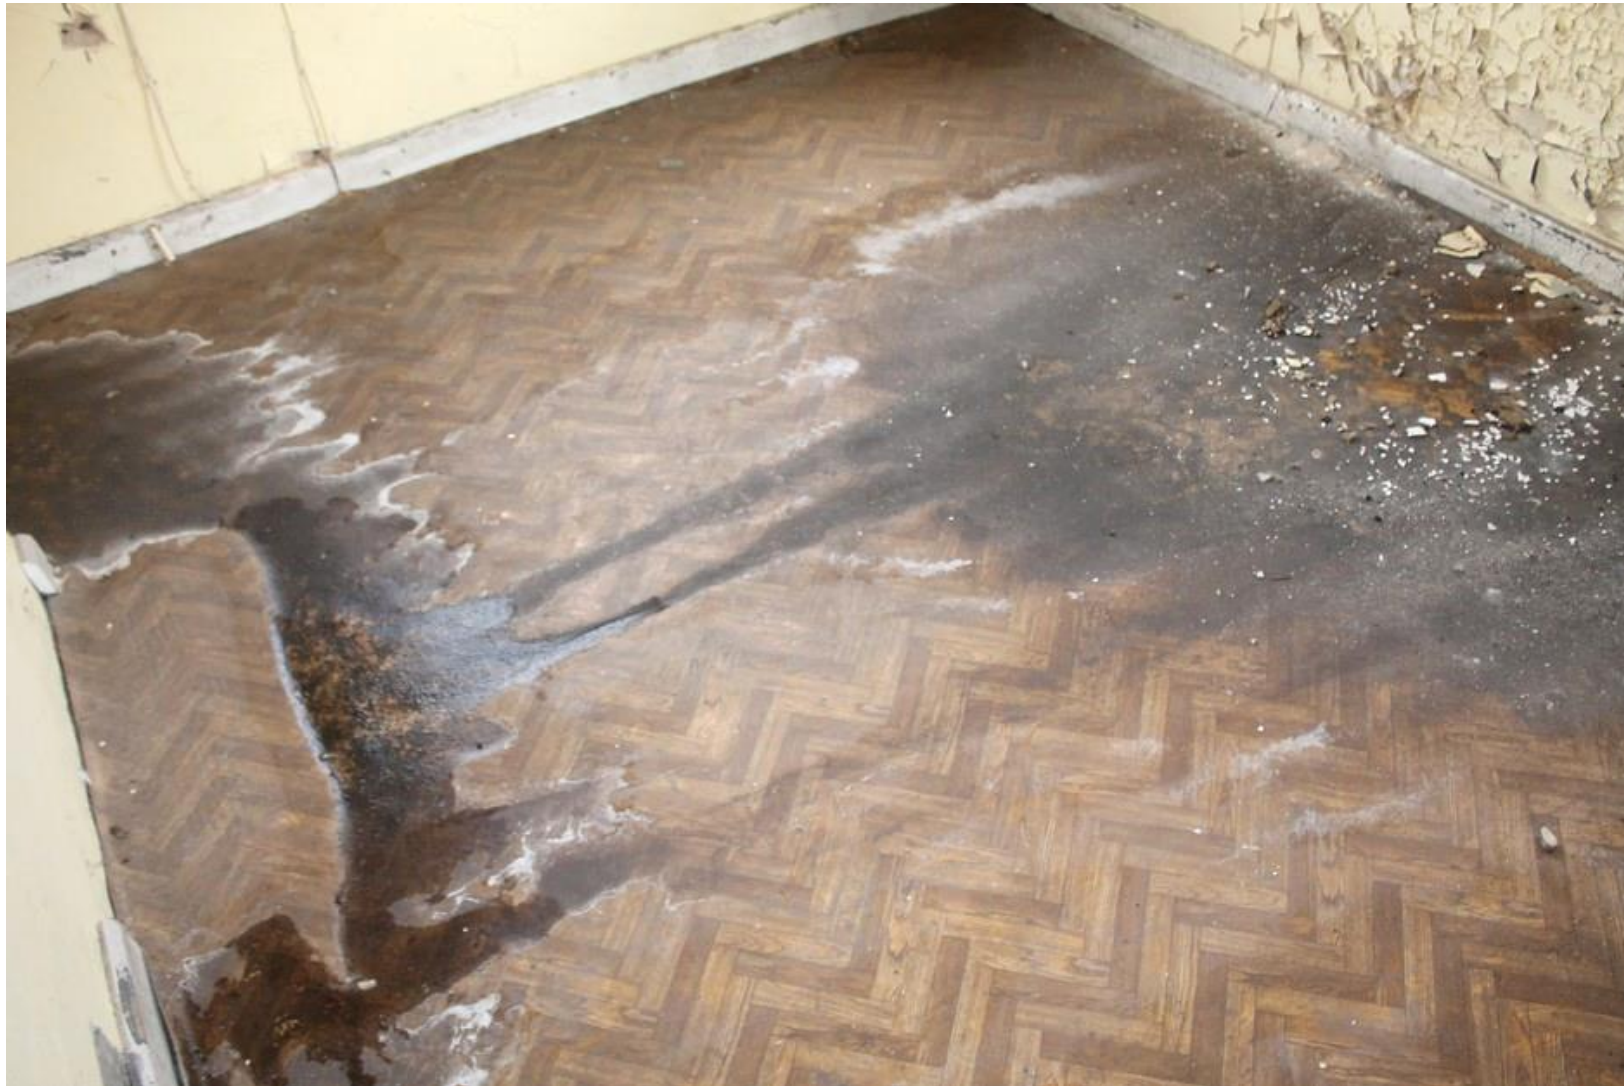
There were stairs to the first floor, where the rooms were largely empty. There was evidence of water ingress in first floor rooms at the front of the building (Photographs 4 & 5). Elsewhere, towards the rear of the first floor, the ceiling was lined with reflective foil (Photograph 6), and I found plant fertiliser containers and compost.

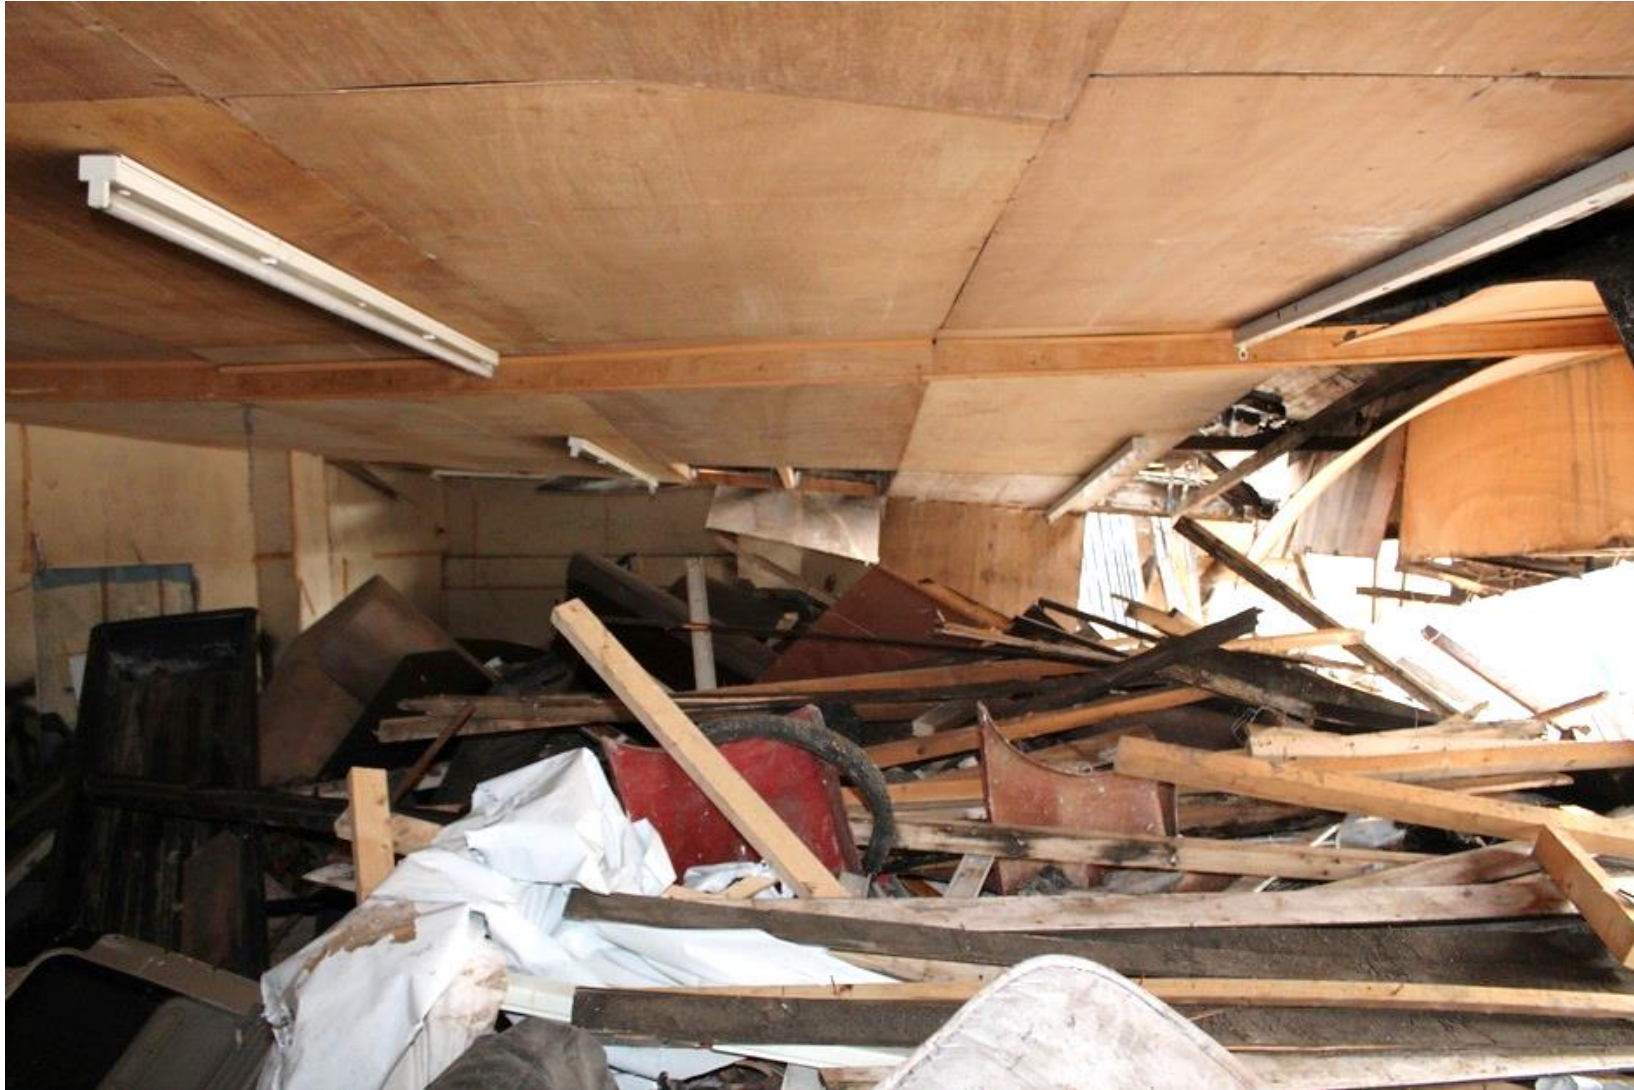
**Photograph 7**

There was open access from the ground floor into the extension, where it communicated with the main building. Photograph 7 is a view into the area beneath roof A, where most of the space was filled with a pile of materials, that appeared to be similar in content to that in the main building. Photographs 8 and 9 are views above the suspended ceiling that had been installed beneath the roof, with timber beams secured by joist hangers to the original timber frame of the roof, to support a timber sheet ceiling. Photograph 10 is a view from within the ceiling void towards the area of roof A where it had failed/collapsed at the east end, adjacent to roof B (as shown in Figures 1-3).

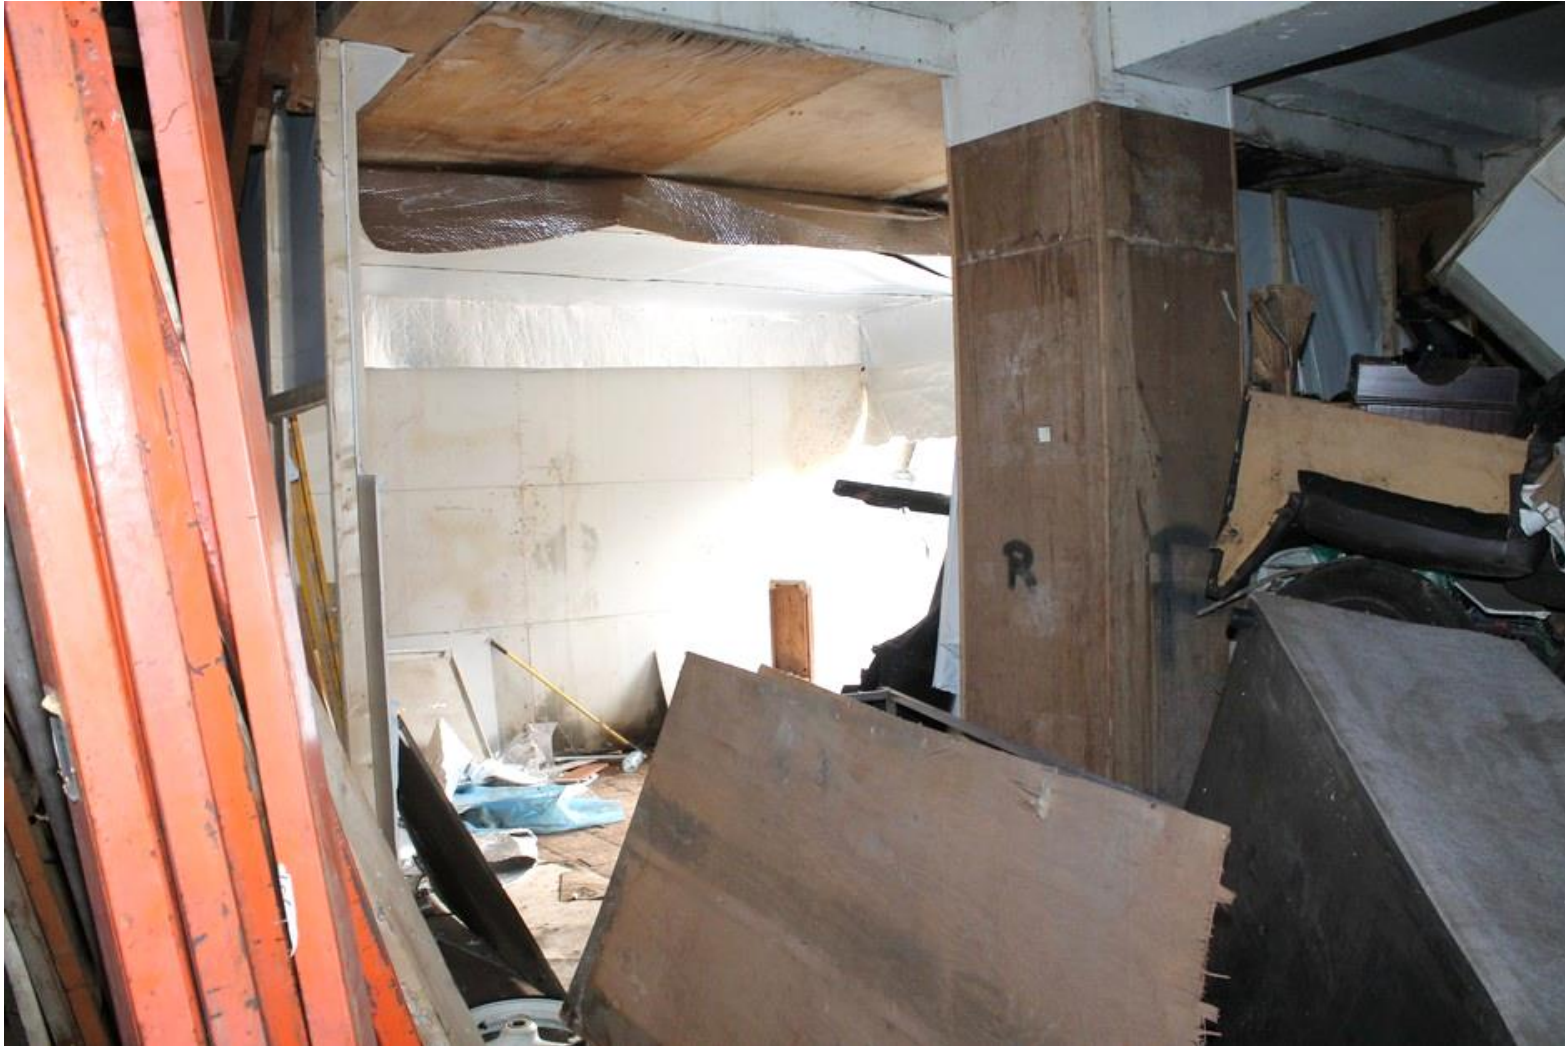
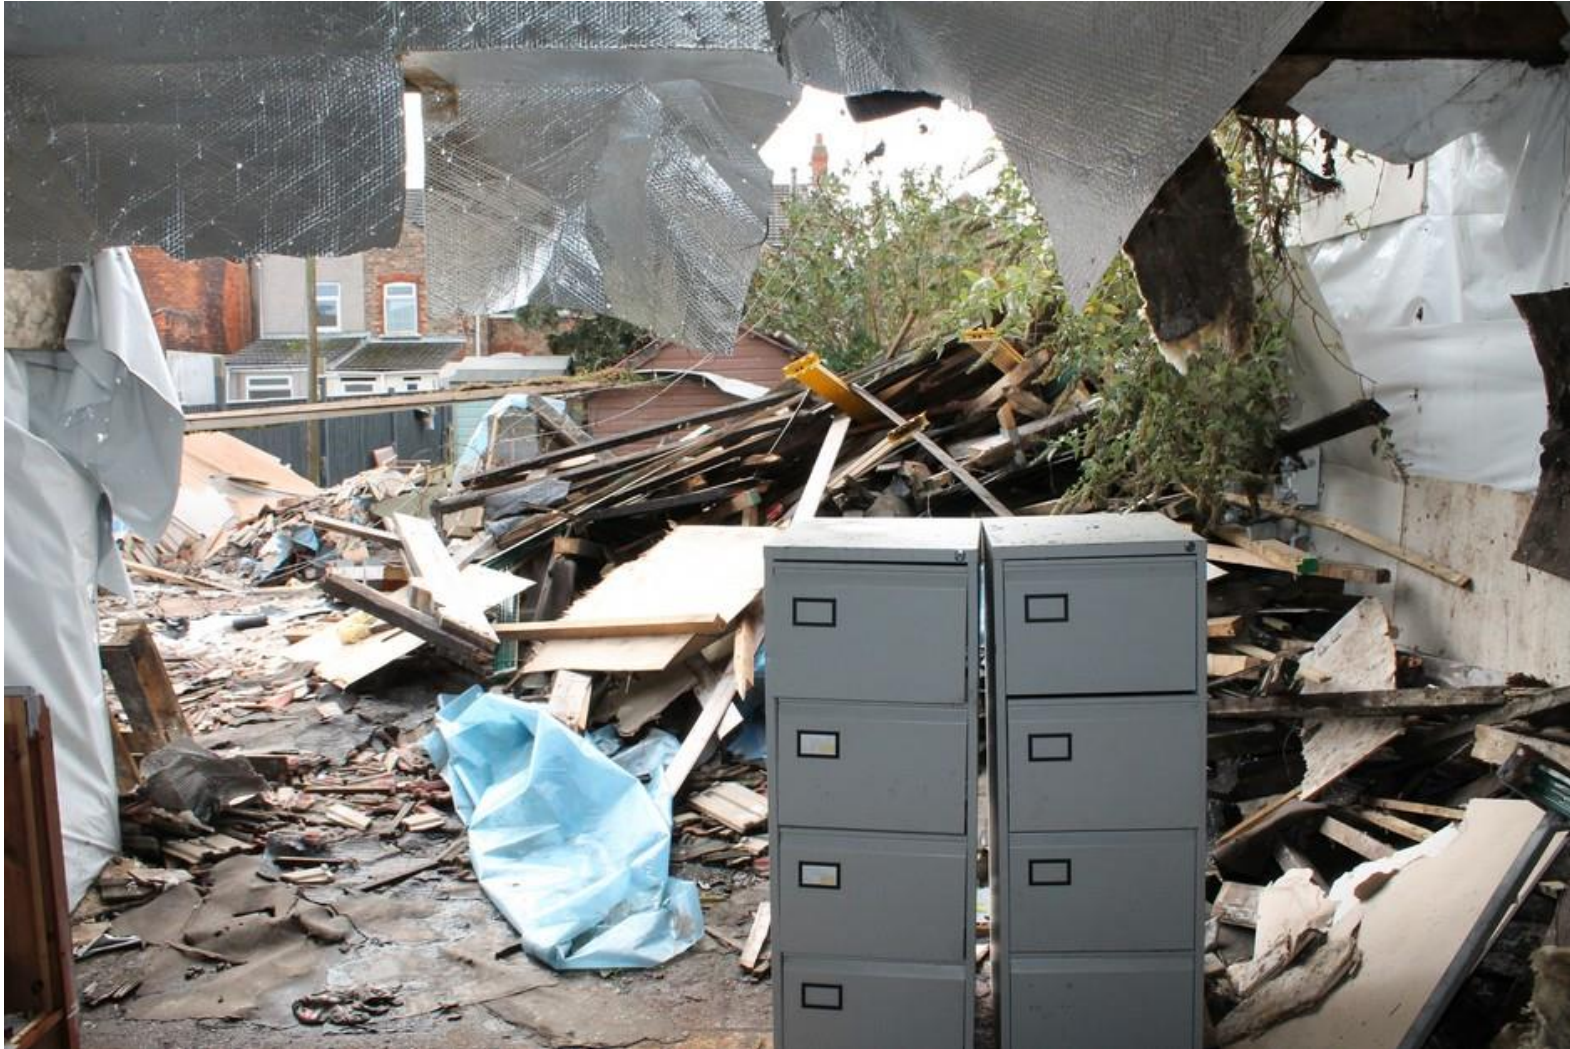
Photographs 11 and 12 show where there was open access that led from the main building into the extension. Roof B was entirely collapsed/missing and the ground beneath was littered with broken tiles and timber sections (Photographs 13-15). Straps had been secured to the east gable wall, to prevent it collapsing into the adjacent playground. Collapsed timbers had been piled up towards the west end and into the area beneath roof A.

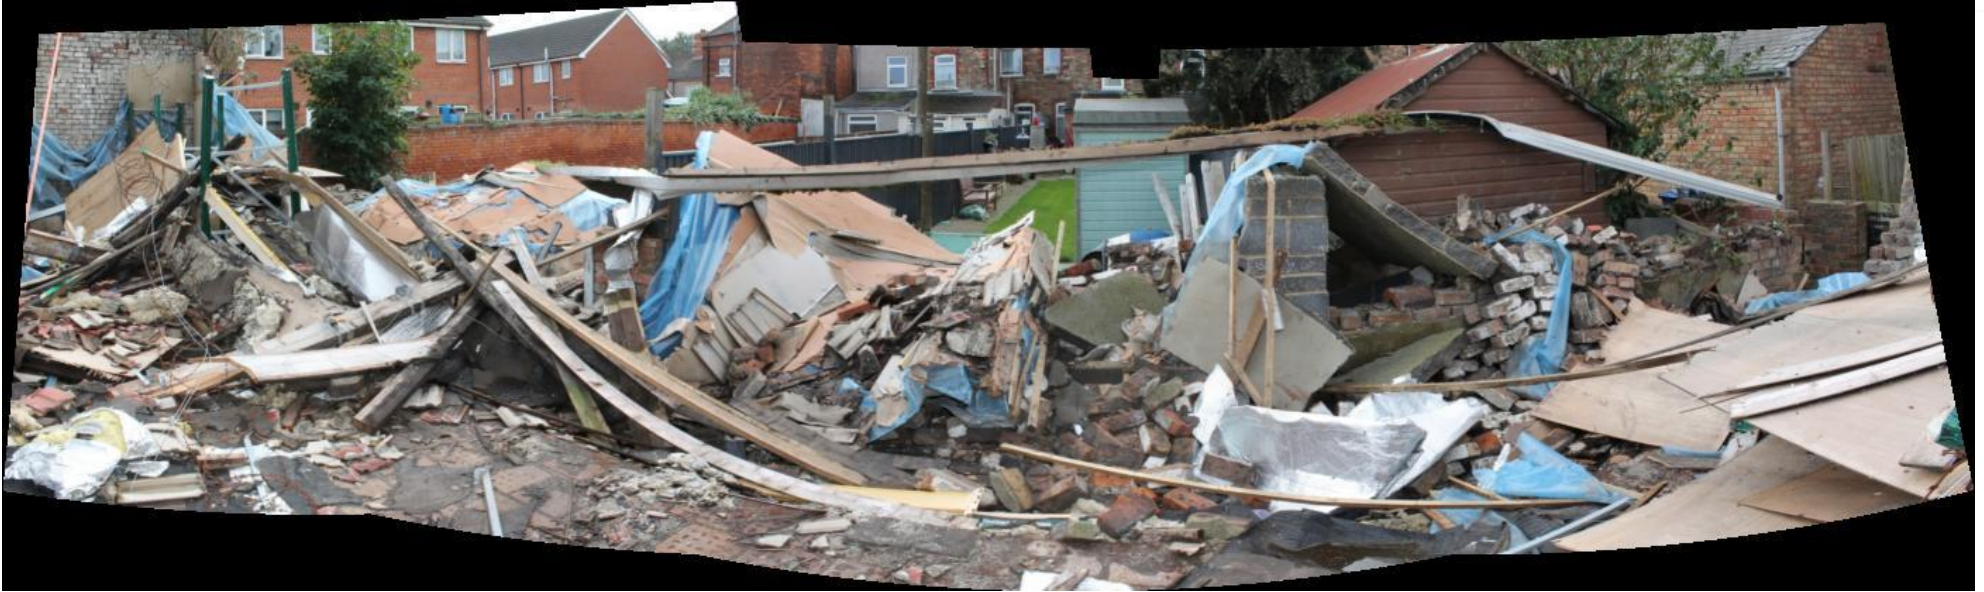
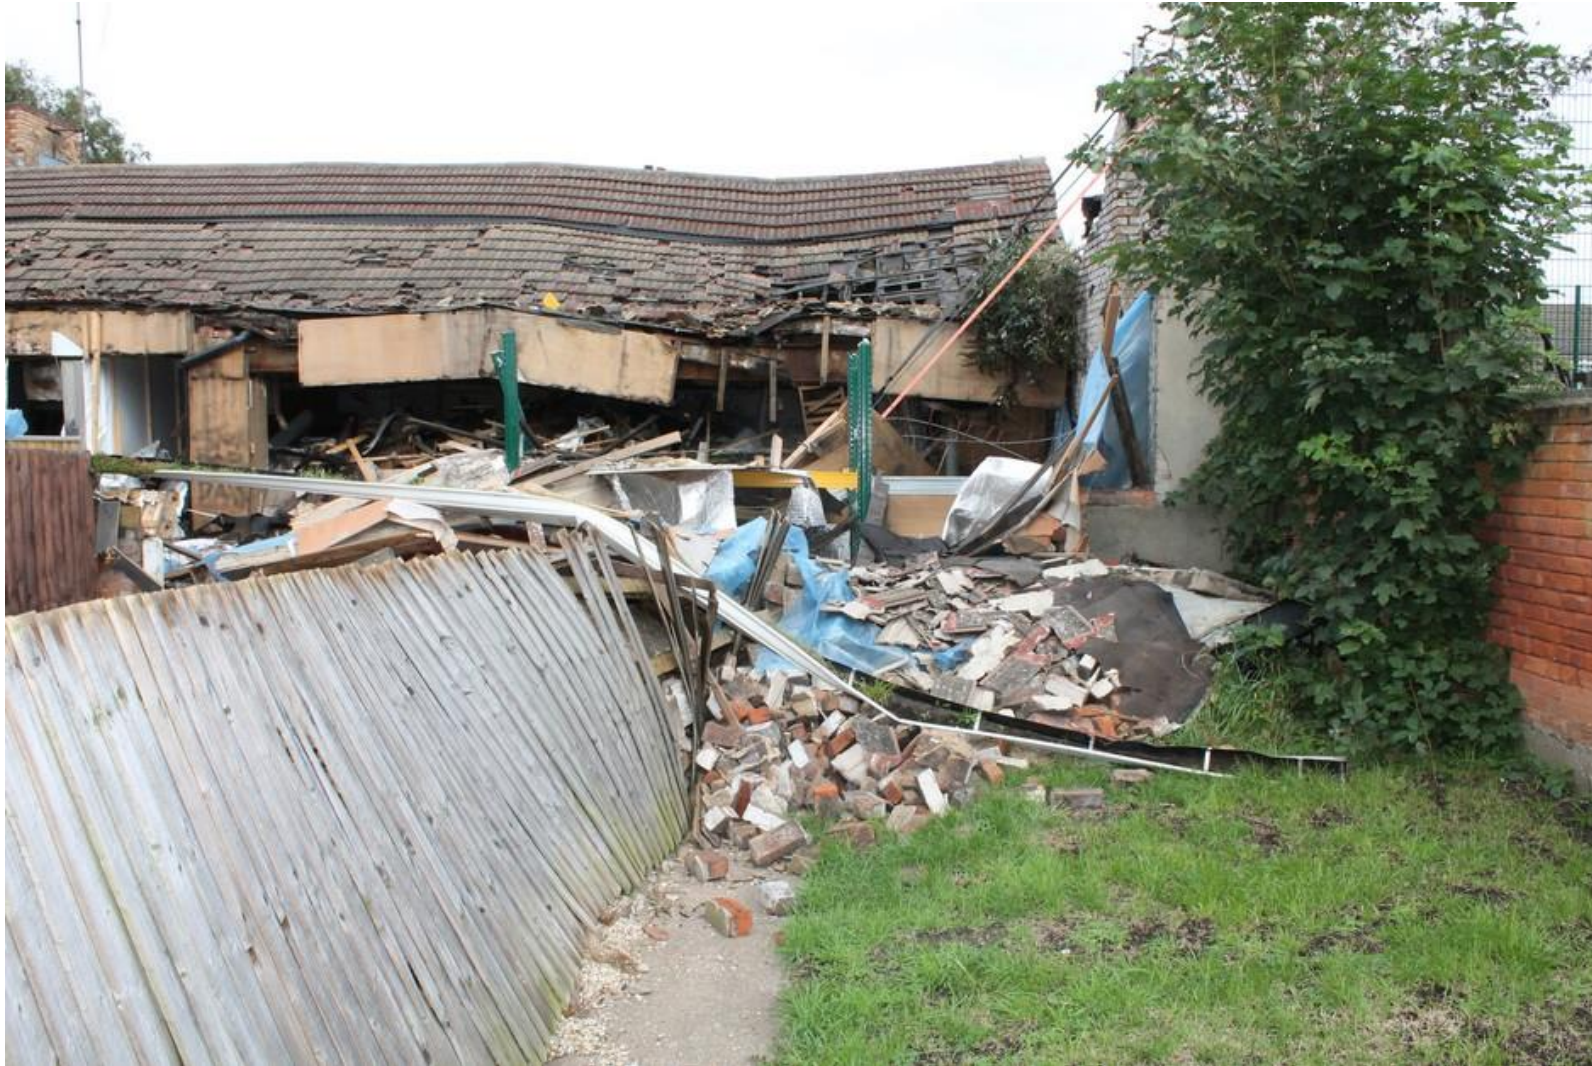
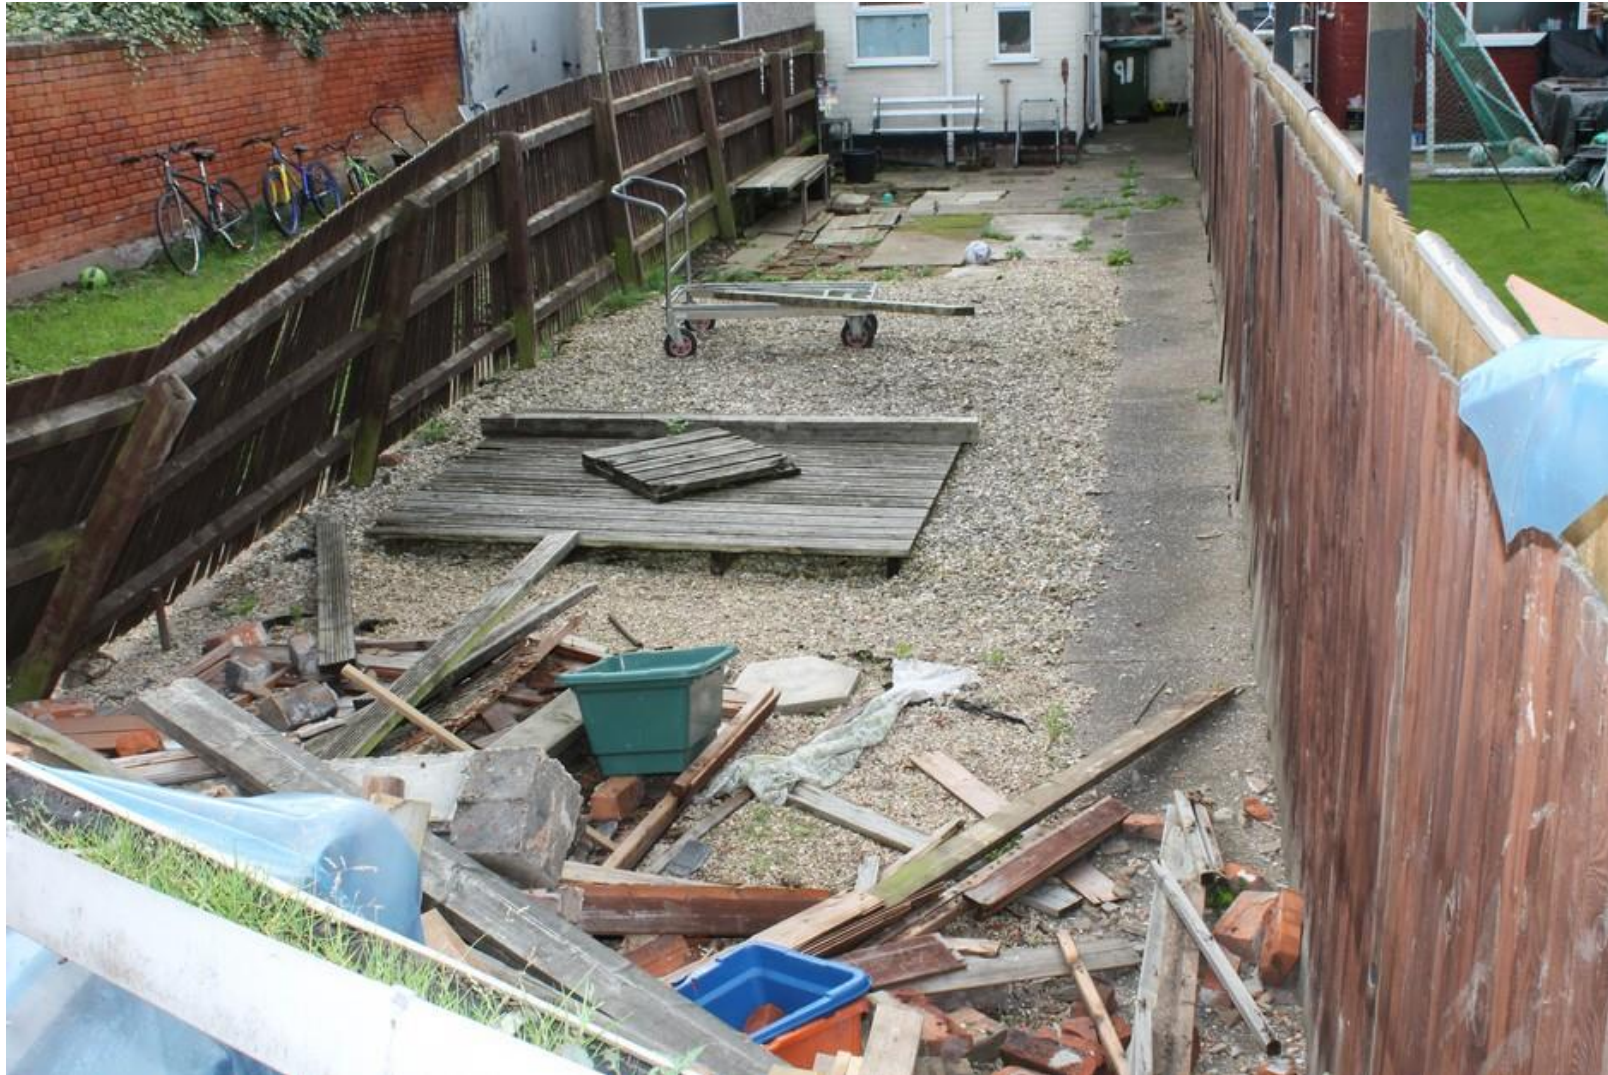
Photograph 16 is a composite image showing where the south elevation of the extension had collapsed into the passageway that had separated the extension from the gardens of the properties on Castle Street. Masonry, guttering and sections of timber had collapsed onto fencing and into the gardens close to the passageway (Photographs 17 & 18), but the debris did not extend beyond a few metres of the passageway, and a timber shed in the garden at [REDACTED] that was relatively close to the passageway, was undamaged (Photograph 19).

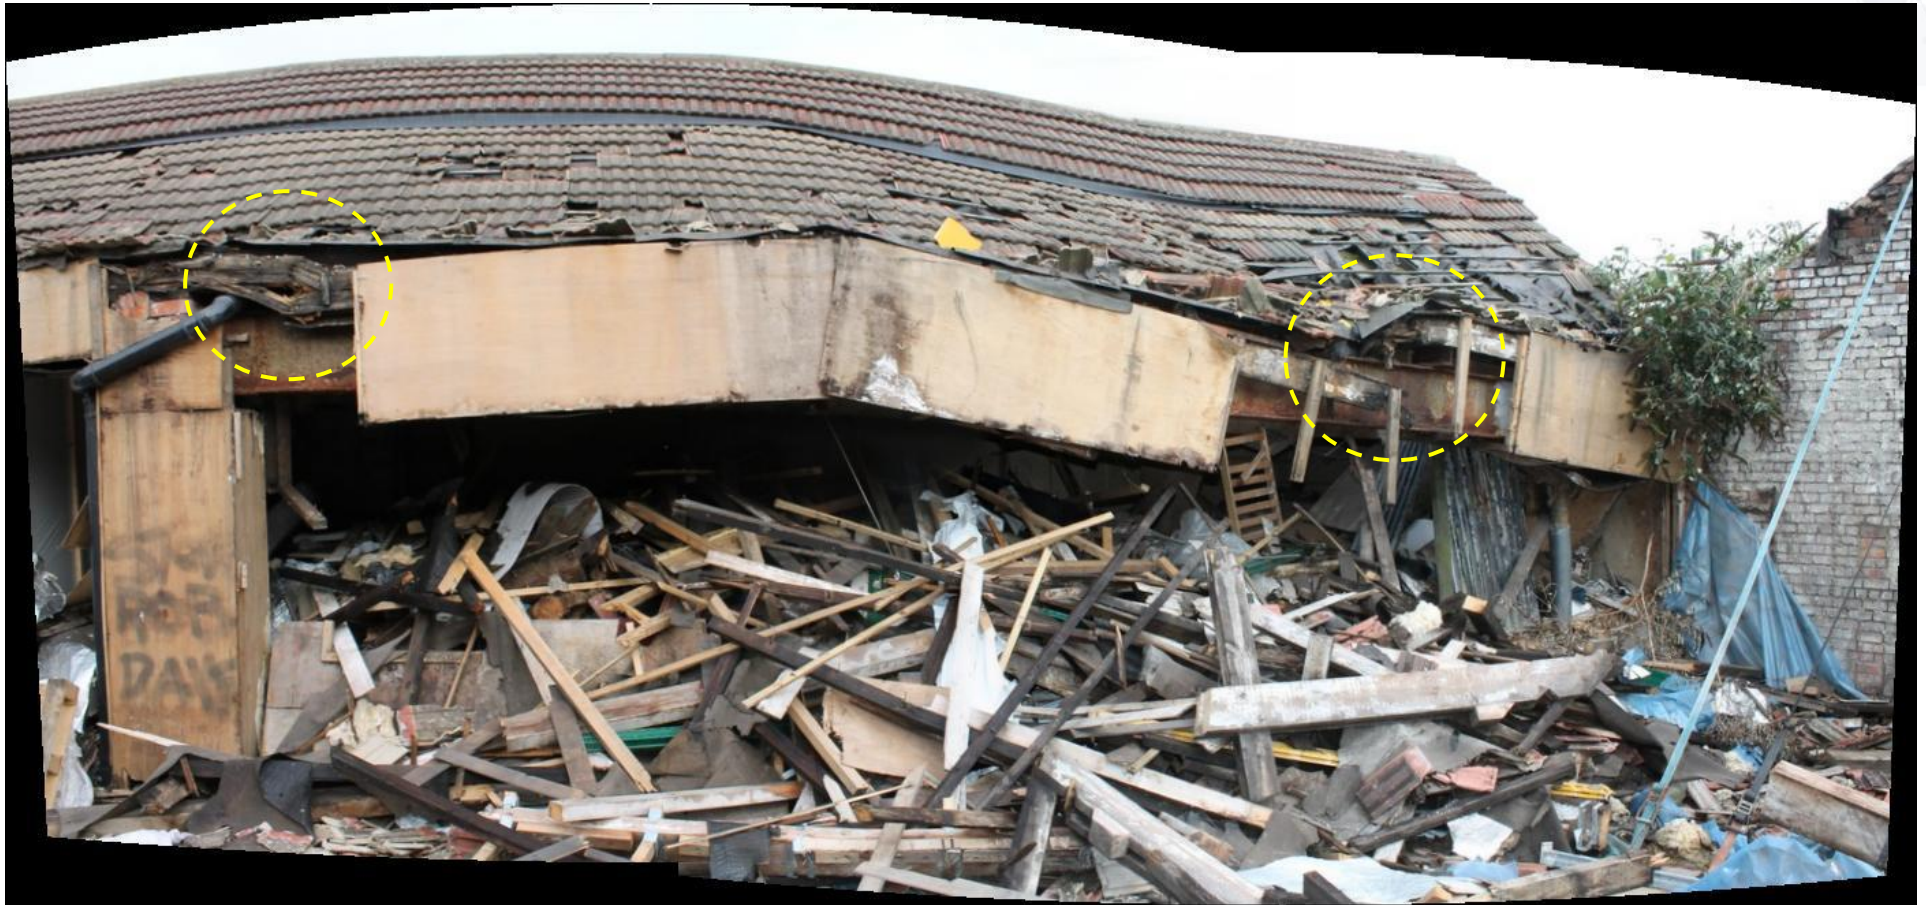
**Photograph 20**

Photograph 20 is a composite view north from the collapsed part of the extension towards roof A, showing two areas where a substantial timber member, aligned east-west, had fractured. The timber in these areas was discoloured, consistent with water damage (Photographs 21 & 22). Inspection of lengths of timber in the area of collapse revealed several sections that had been sawn through and others that had fractured (Photographs 23 & 24).
