# Burgoyne

Our Ref: 713807/CLG

27 October 2023

**INSURED: ANDREAS INVESTMENTS LTD**  
**INCIDENT: BUILDING COLLAPSE AT 68A HAROLD STREET, GRIMSBY, DN32 7NQ**  
**INCIDENT DATE: 13 SEPTEMBER 2023**

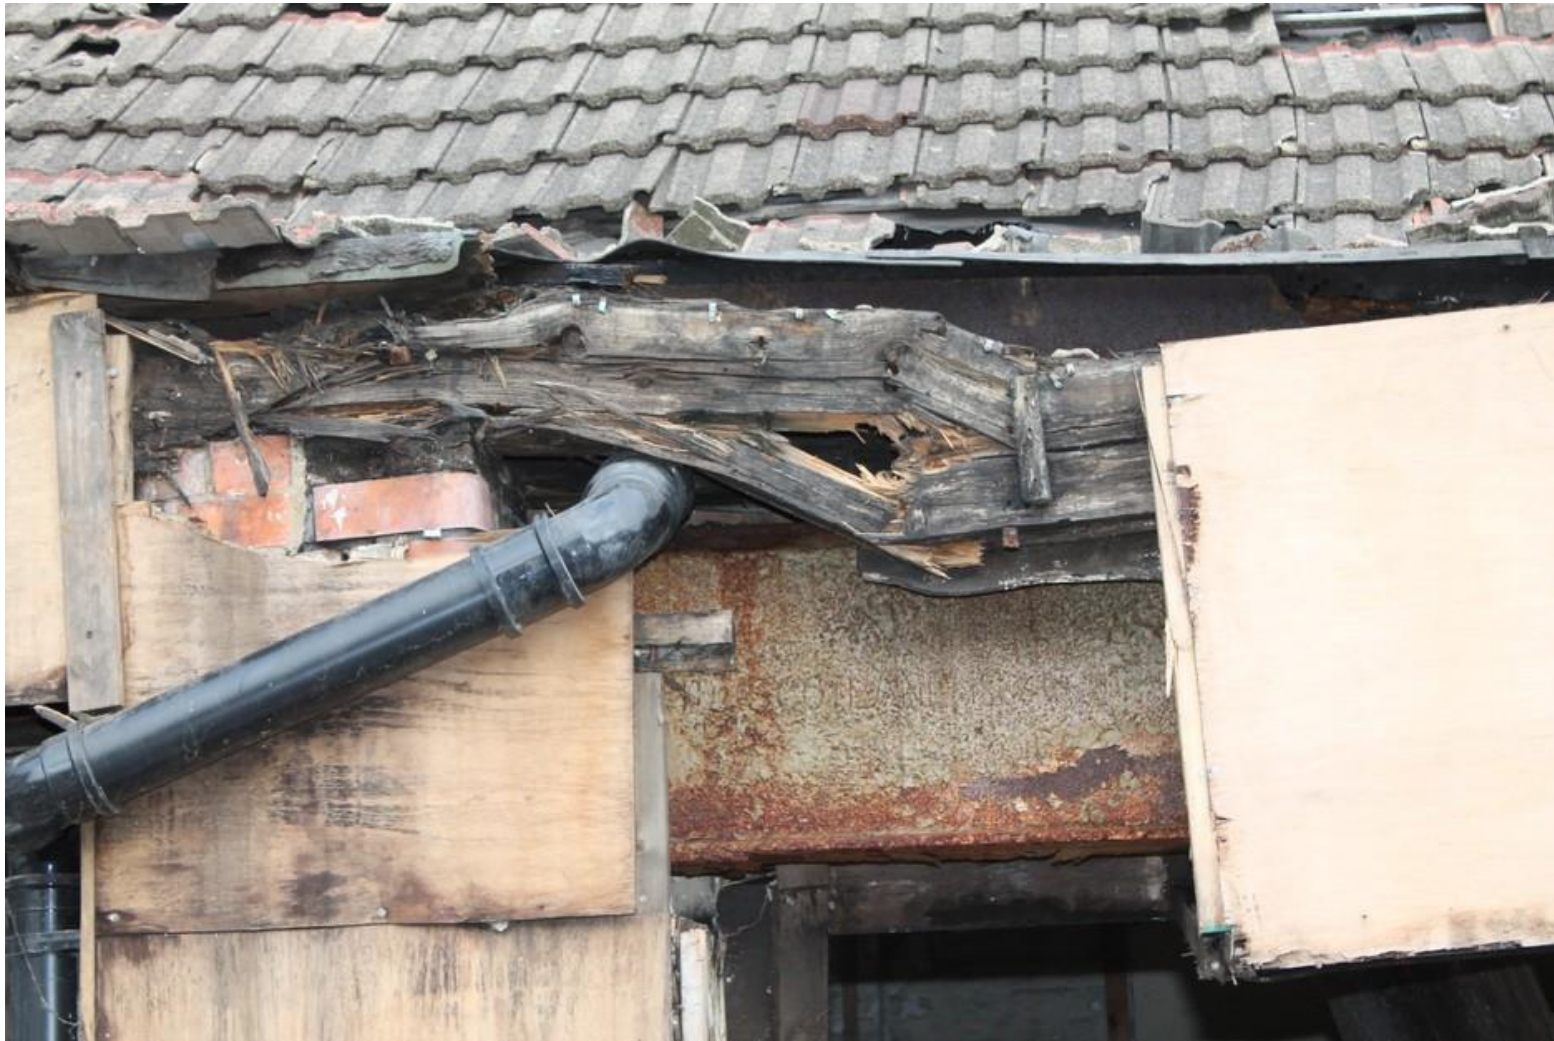
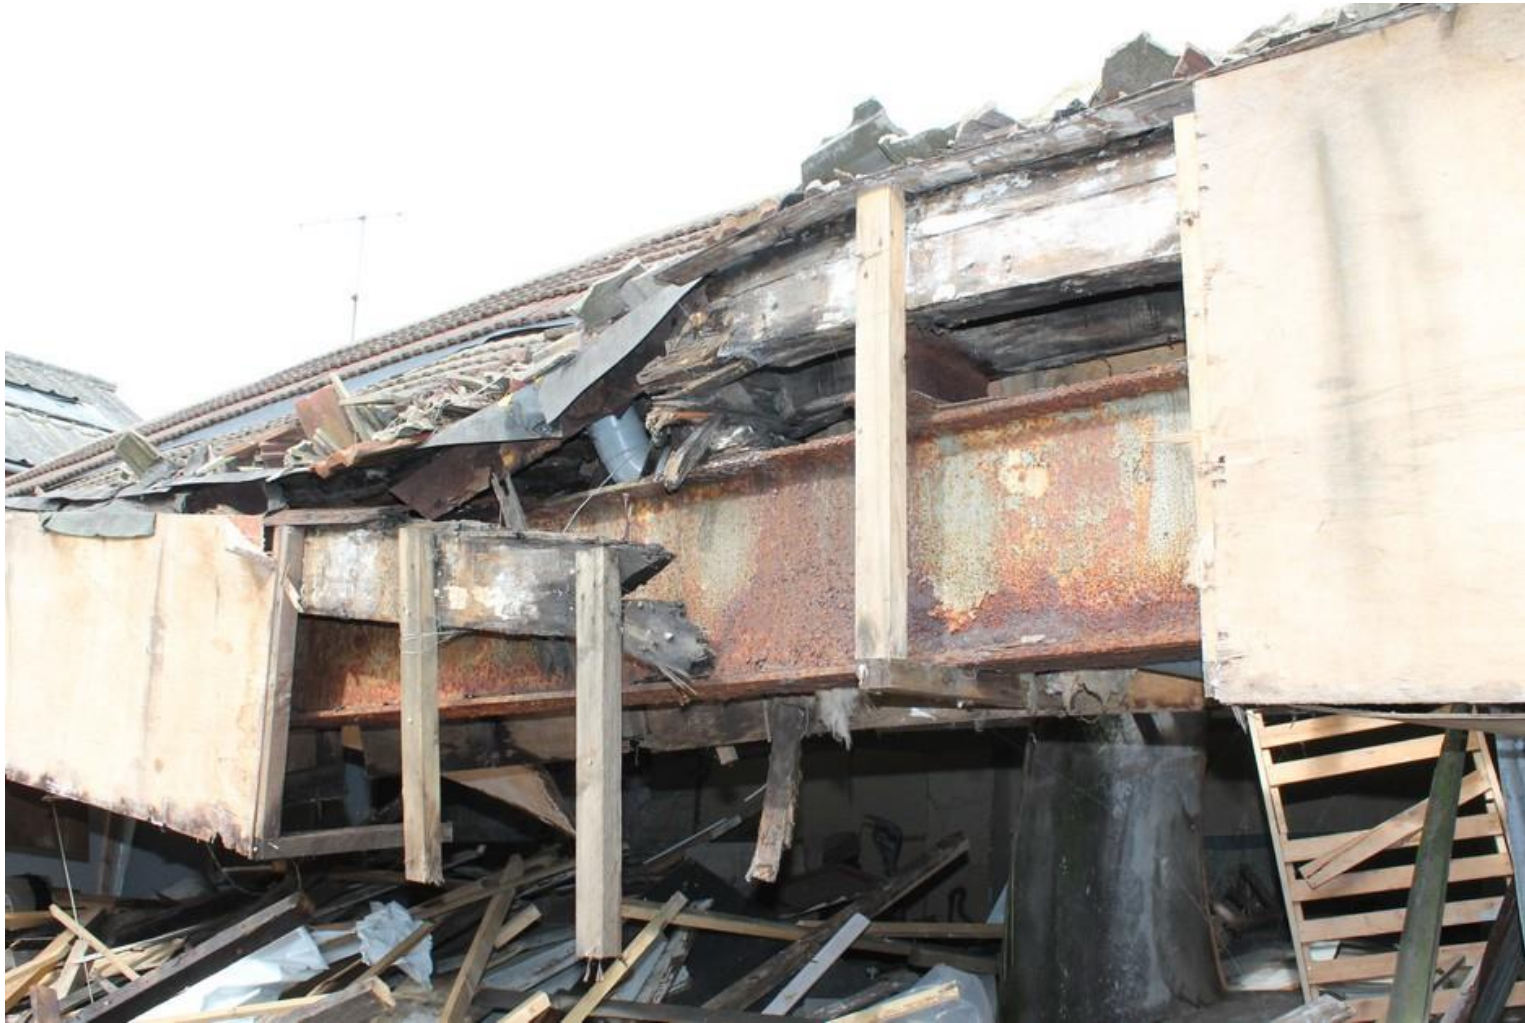
Photograph 20 is a composite view north from the collapsed part of the extension towards roof A, showing two areas where a substantial timber member, aligned east-west, had fractured. The timber in these areas was discoloured, consistent with water damage (Photographs 21 & 22). Inspection of lengths of timber in the area of collapse revealed several sections that had been sawn through and others that had fractured (Photographs 23 & 24).

Thus, there is no evidence to suggest that the cause of the collapse was related to an explosion. Rather, collapse due to structural failure would explain the damage I observed and the description of [REDACTED]. In that regard, part of roof A had failed several years ago, there was evidence of water ingress into the main building, via the roof, and where a structural timber beam between the two roofs of the extension had fractured, discolouration of the timber looked consistent with water damage. It had also reportedly been raining in the area during the days leading up to the incident. There was clear evidence indicating that the main building and the extension had been used to cultivate cannabis, consistent with [REDACTED] account that a cannabis farm had been discovered several years ago. This had involved modifying the building by lining surfaces with reflective foil, and may also have involved installing suspended ceilings, including in the extension, thus adding additional weight to the original timber structure that supported the roof. Whilst the sawn sections of timber I saw amongst the collapsed debris may have been cut when straps were secured to the east gable wall after the incident, I cannot rule out the possibility that the roof structure had been modified/changed, and thus weakened, prior to the collapse.
