Our Ref: 713807/CLG

27 October 2023

**INSURED: ANDREAS INVESTMENTS LTD**  
**INCIDENT: BUILDING COLLAPSE AT 68A HAROLD STREET, GRIMSBY, DN32 7NQ**  
**INCIDENT DATE: 13 SEPTEMBER 2023**

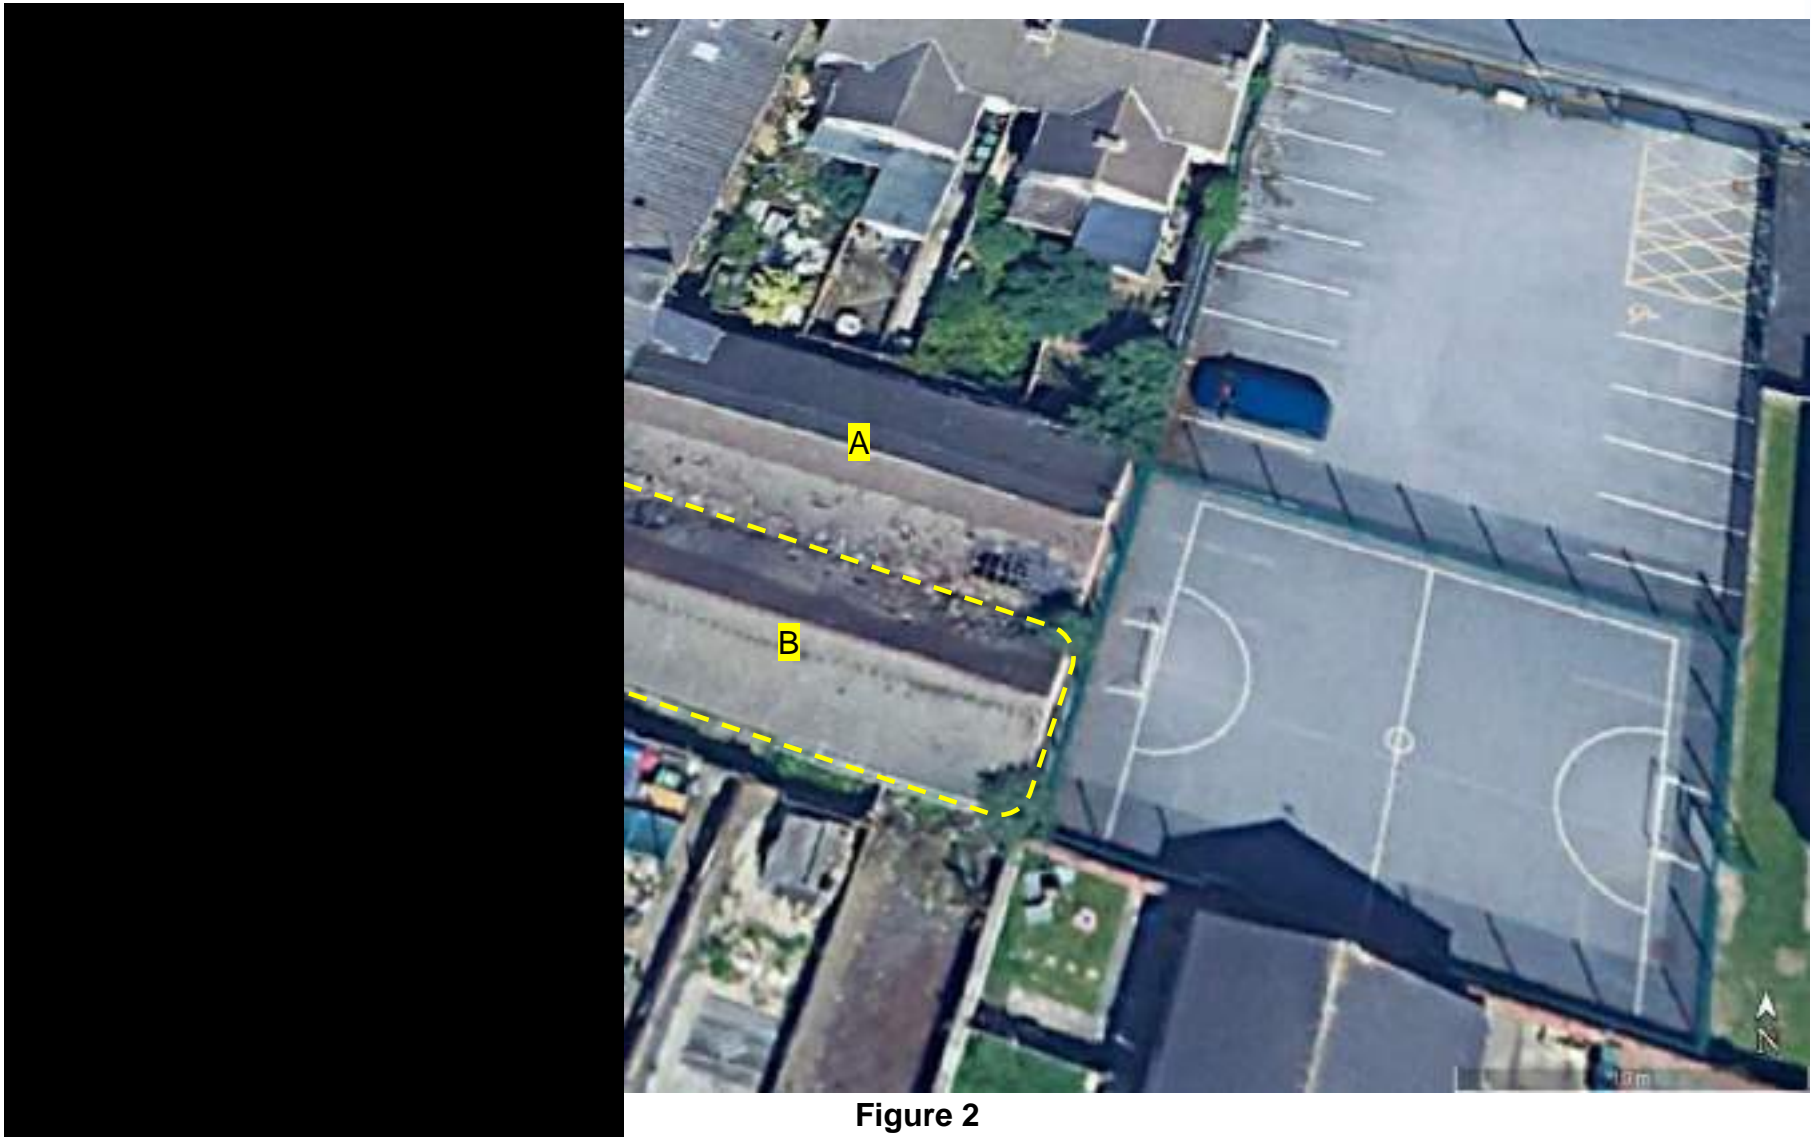
**Figure 2**

Figure 2 is a closer aerial view of the extension, showing damage to roof A, where tiles were missing/dislodged and there was a substantial hole at the east end, adjacent to roof B. I have appended an historical aerial image, which shows similar damage to the roof in September 2019 (Figure 3).

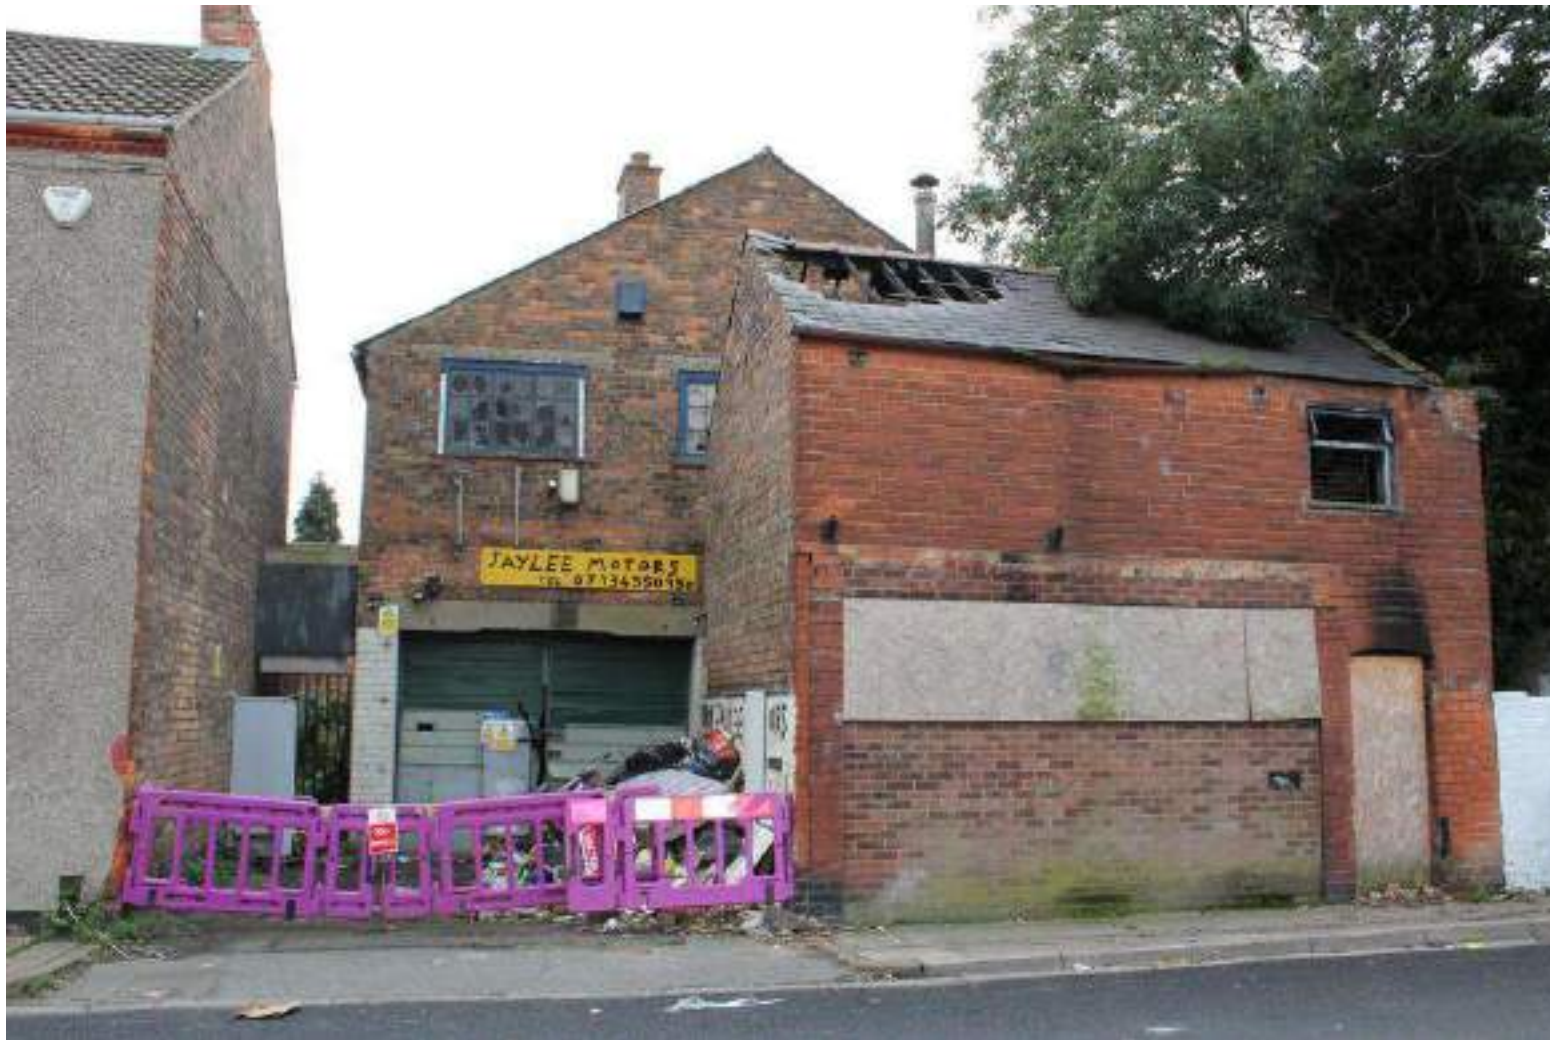
**Photograph 1**

Photograph 1 is a view from Harold Street towards the front of the loss address. A separate building, which I understand was part of the premises, had evidently suffered a previous fire.

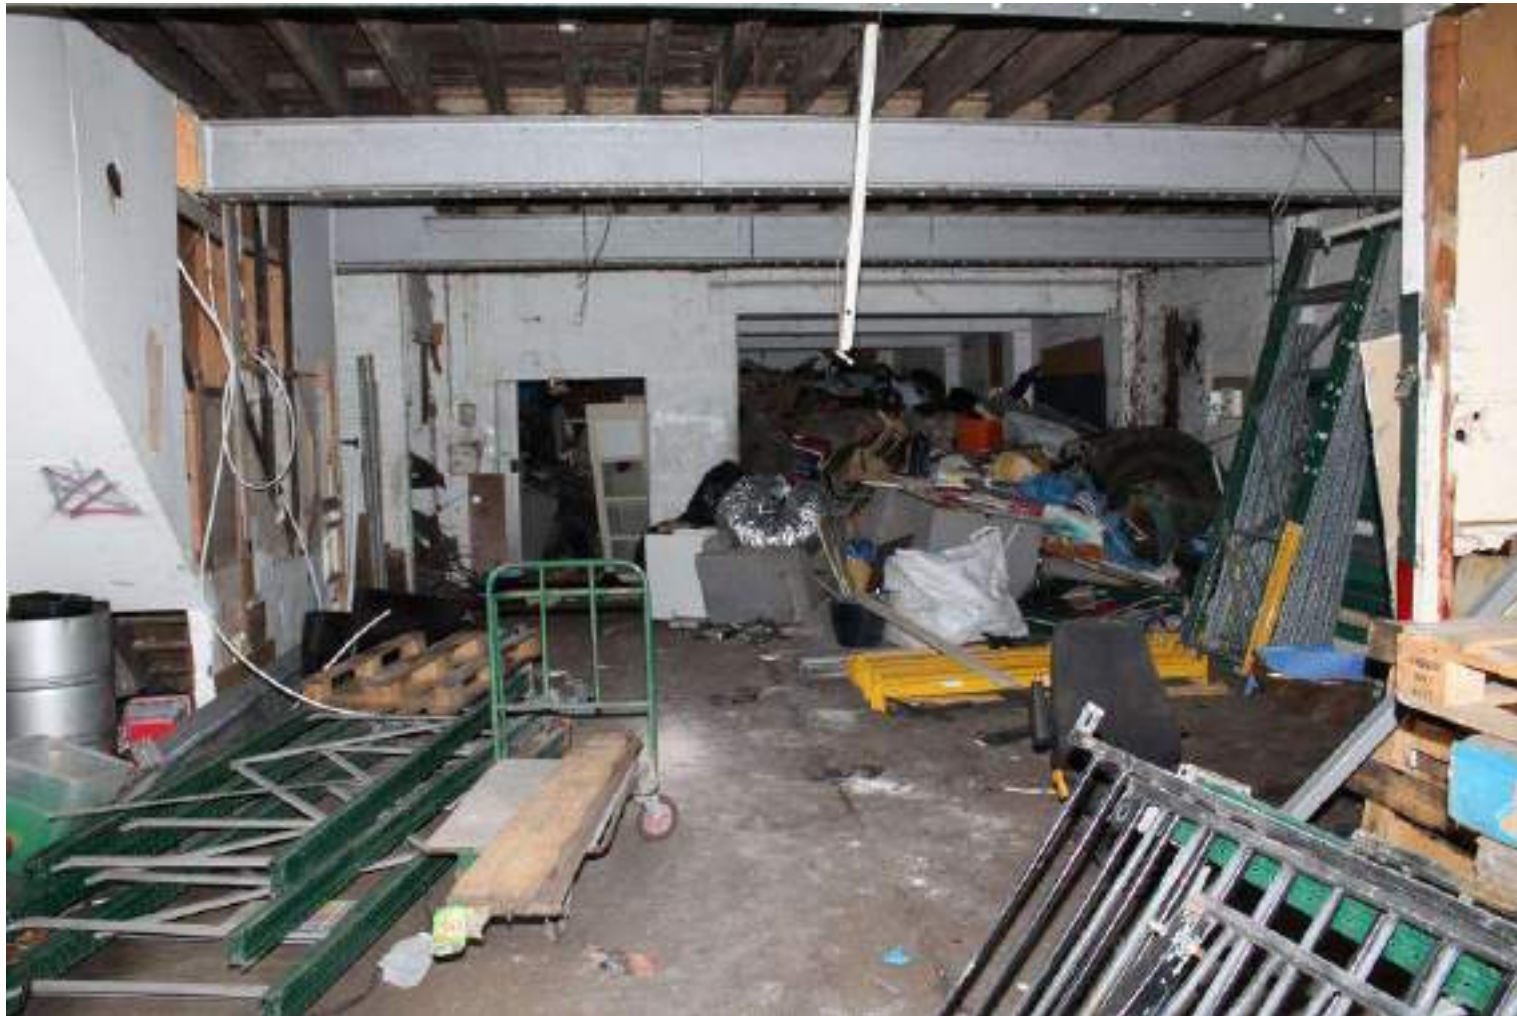
**Photograph 2**

Photograph 2 is a view from the front entrance into the ground floor area of the main building. The mains electrical supply entered the property at the front, but the supply equipment downstream of the service head was missing, i.e. there was no mains electrical supply to the fixed wiring in the building. I saw no indication that the property was connected to a mains gas supply; I did not find a gas meter or any gas appliances such as a boiler. The rear part of the ground floor was essentially filled with a large pile of what appeared to be general waste, including car parts, tyres and assorted items (Photograph 3), and this area was not accessible.

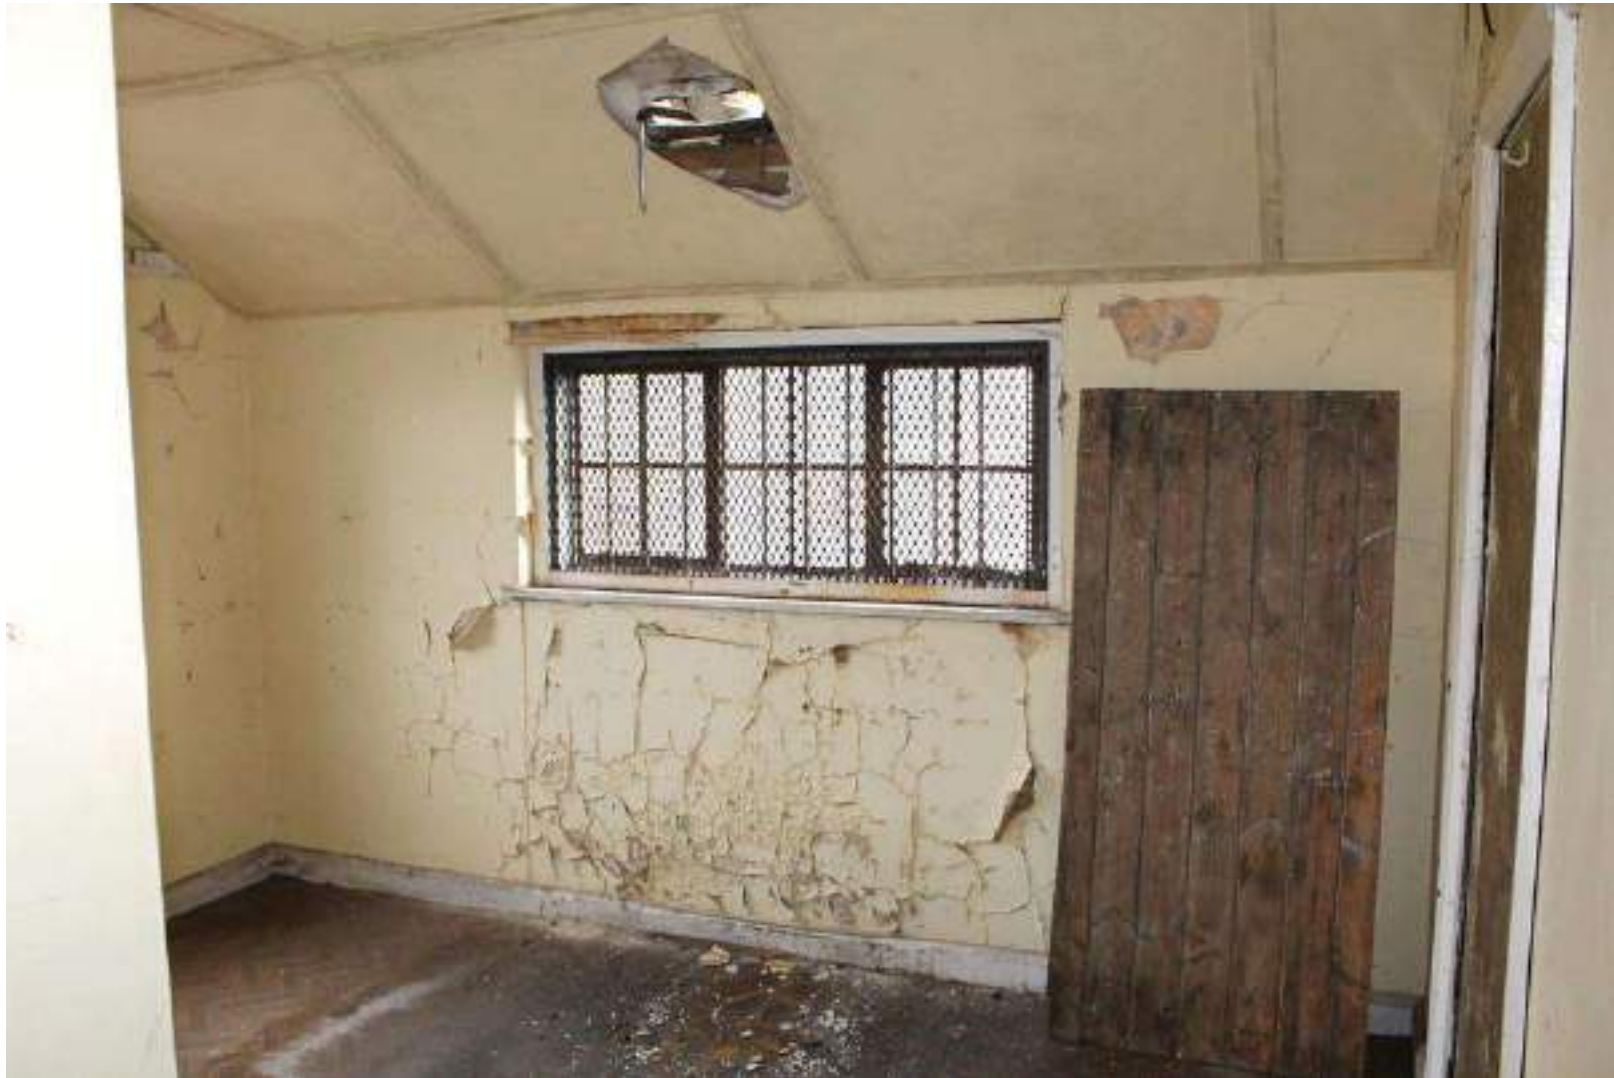
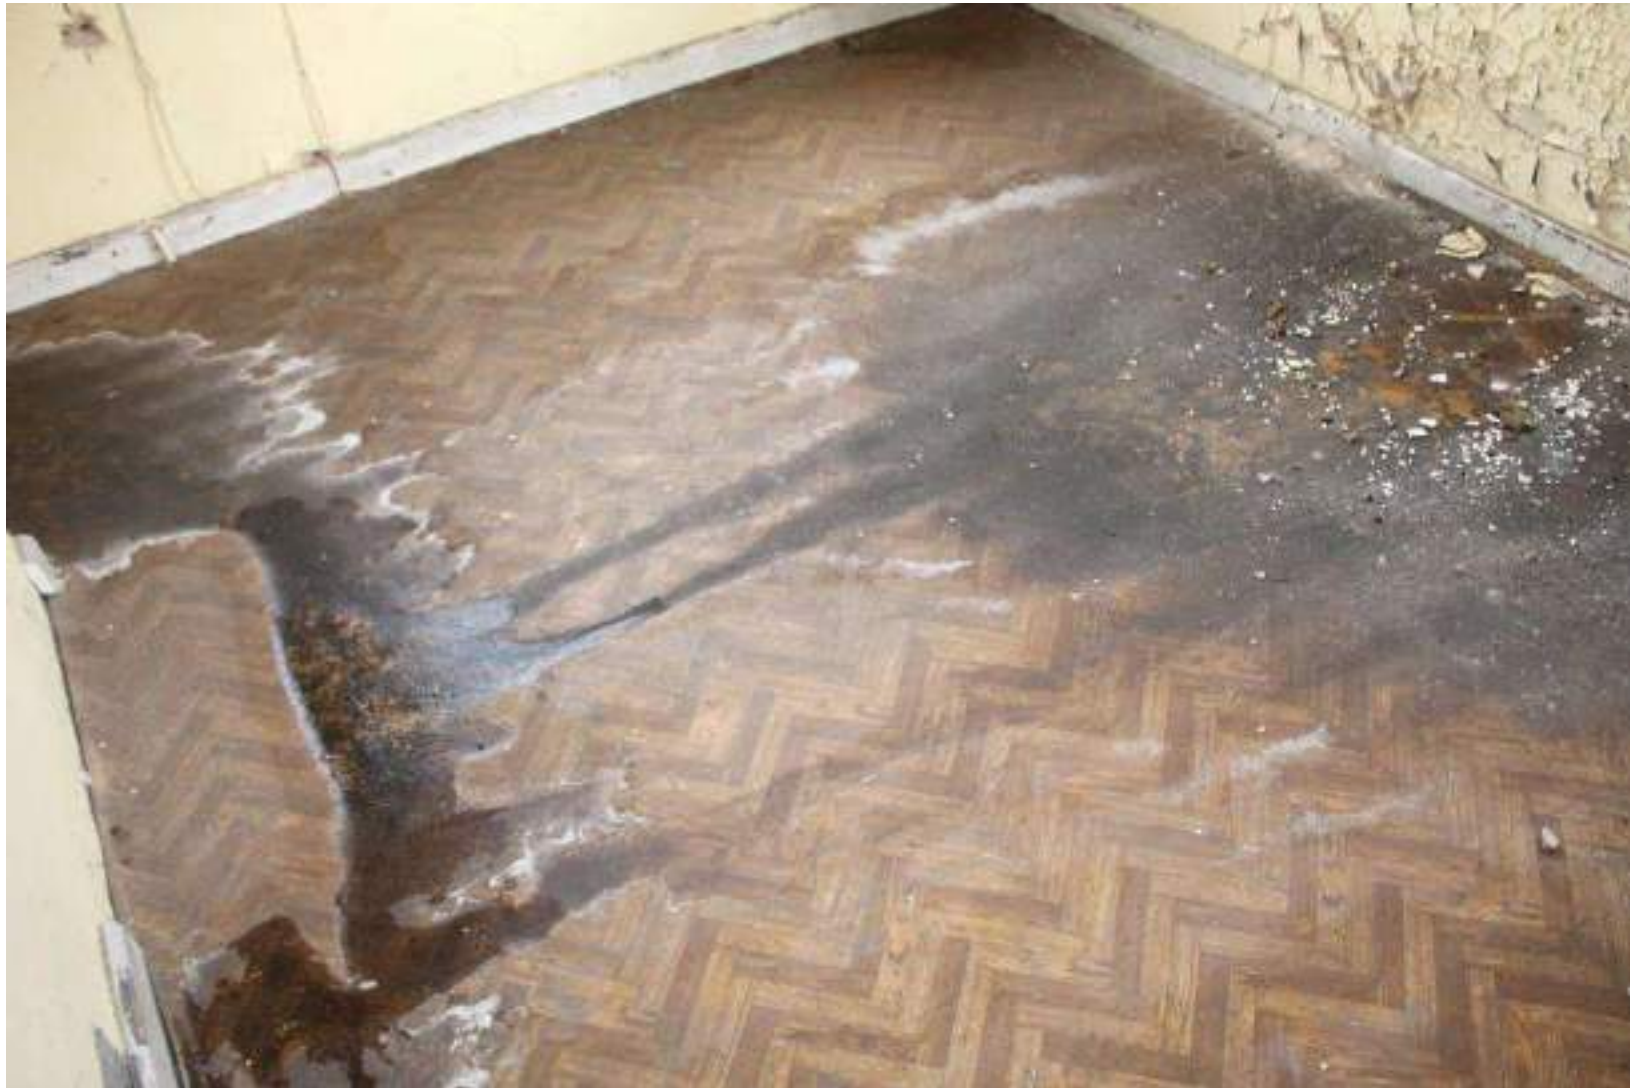
There were stairs to the first floor, where the rooms were largely empty. There was evidence of water ingress in first floor rooms at the front of the building (Photographs 4 & 5). Elsewhere, towards the rear of the first floor, the ceiling was lined with reflective foil (Photograph 6), and I found plant fertiliser containers and compost.

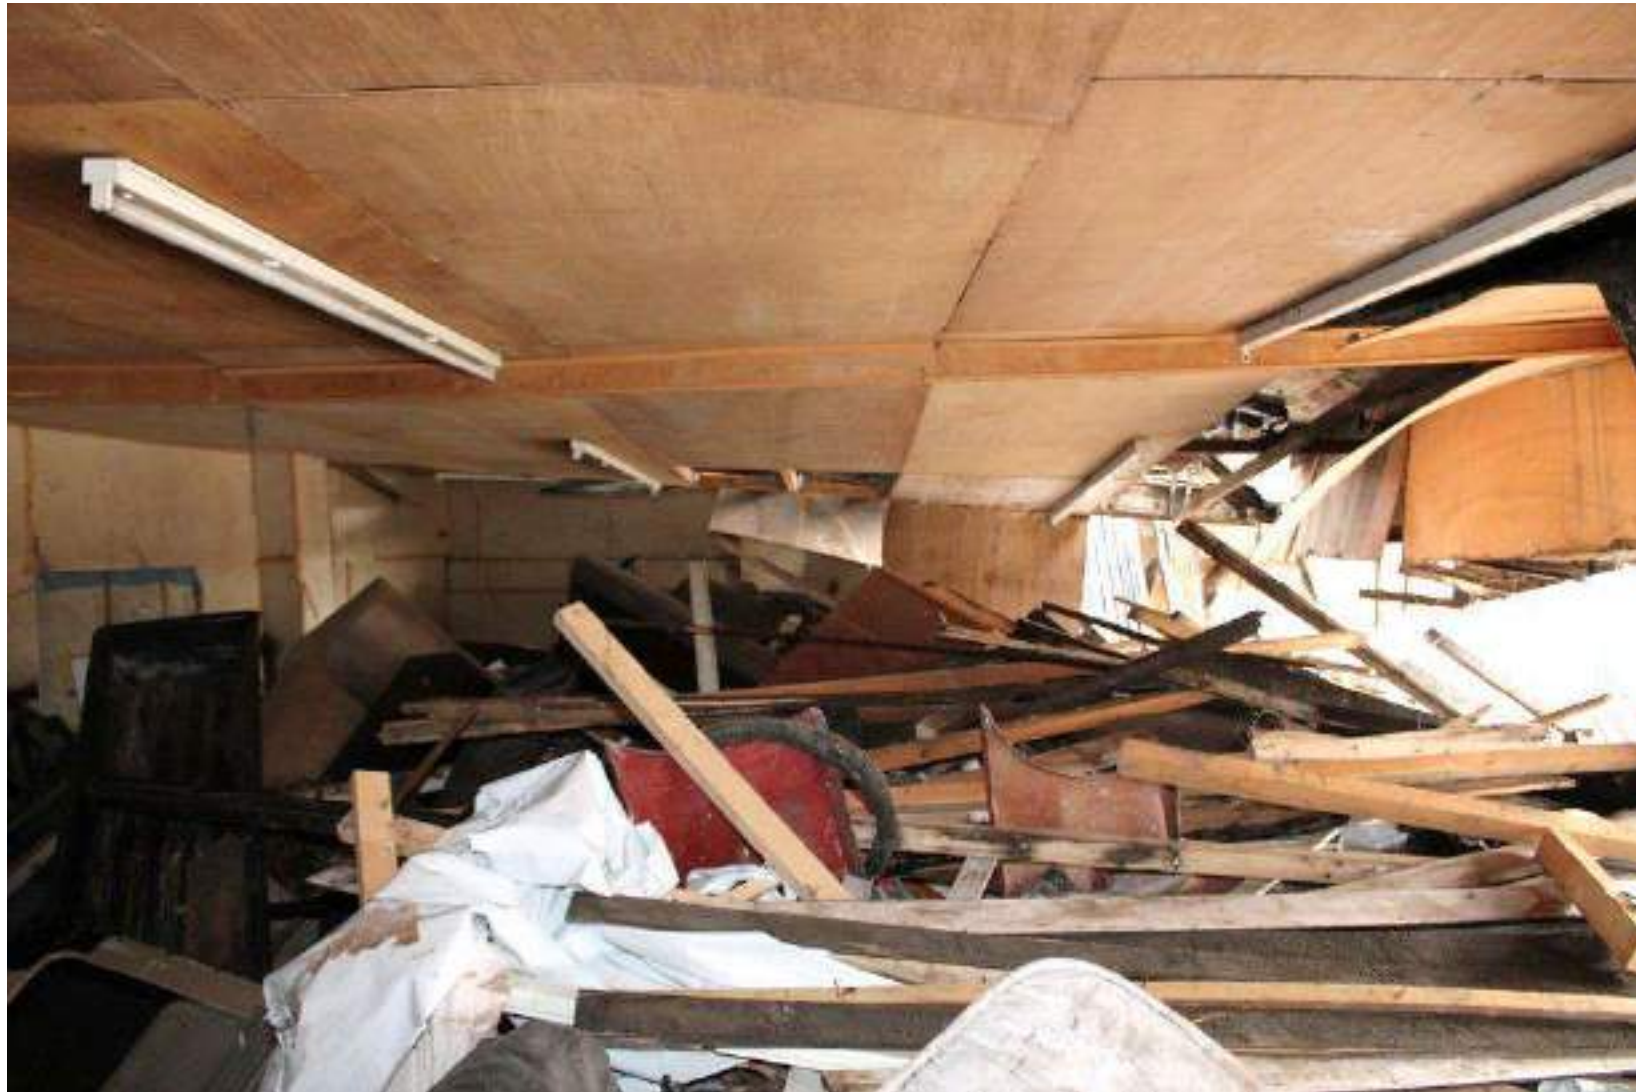
**Photograph 7**

There was open access from the ground floor into the extension, where it communicated with the main building. Photograph 7 is a view into the area beneath roof A, where most of the space was filled with a pile of materials, that appeared to be similar in content to that in the main building. Photographs 8 and 9 are views above the suspended ceiling that had been installed beneath the roof, with timber beams secured by joist hangers to the original timber frame of the roof, to support a timber sheet ceiling. Photograph 10 is a view from within the ceiling void towards the area of roof A where it had failed/collapsed at the east end, adjacent to roof B (as shown in Figures 1-3).

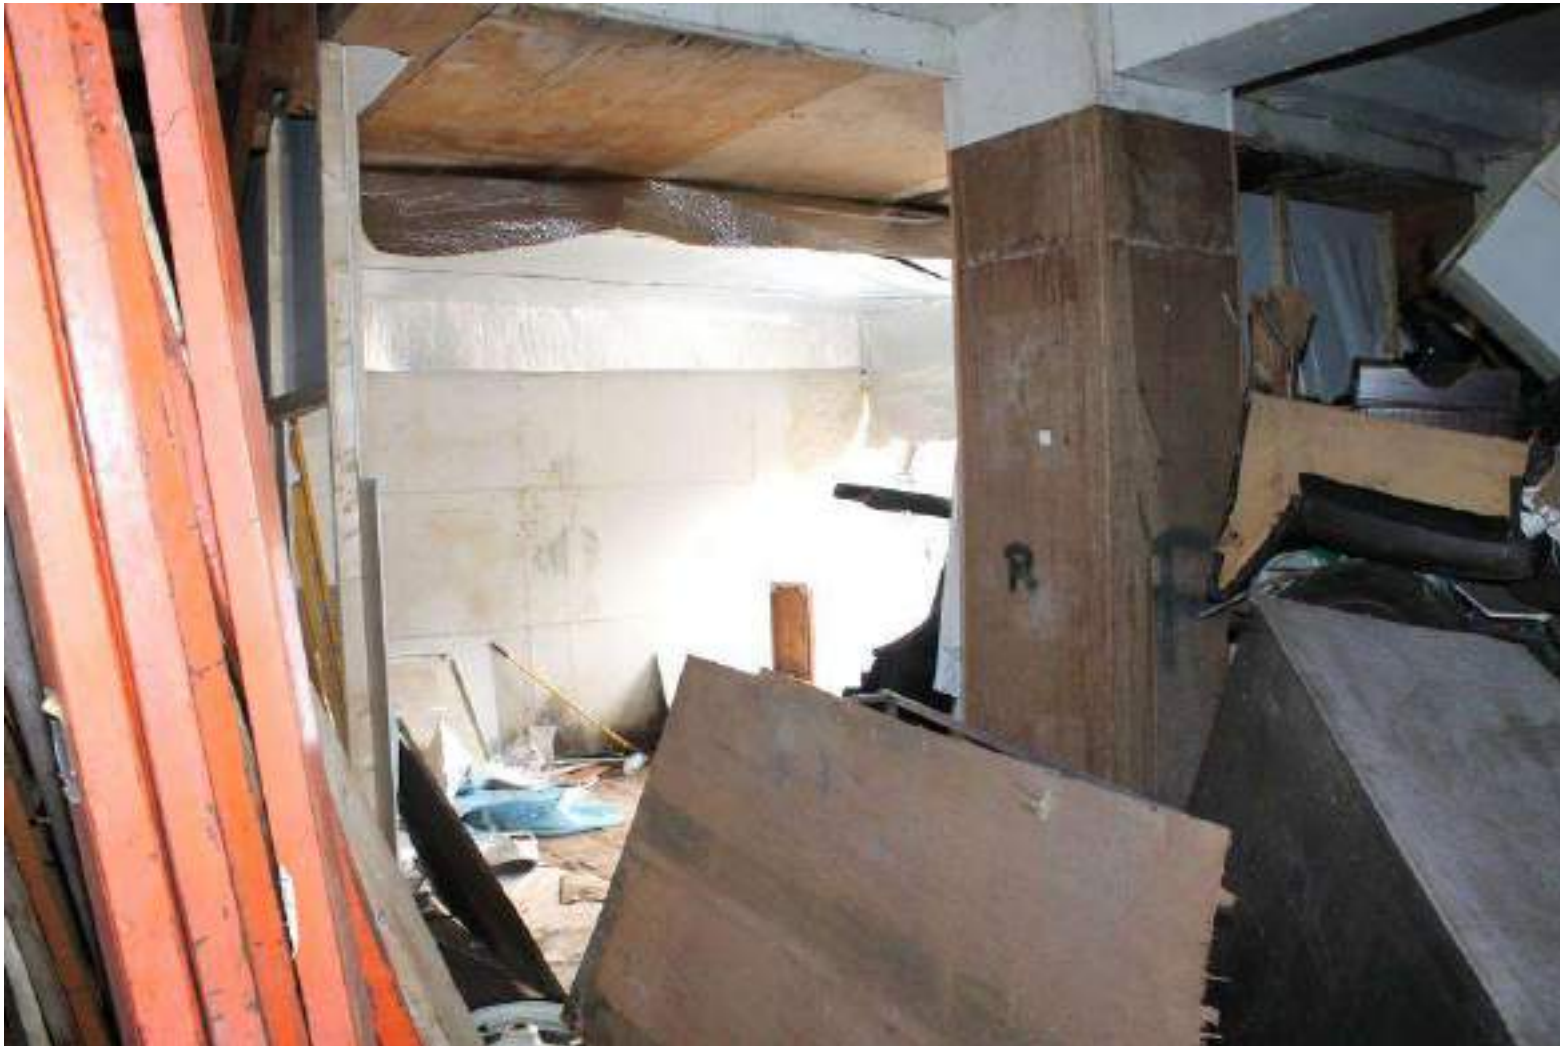
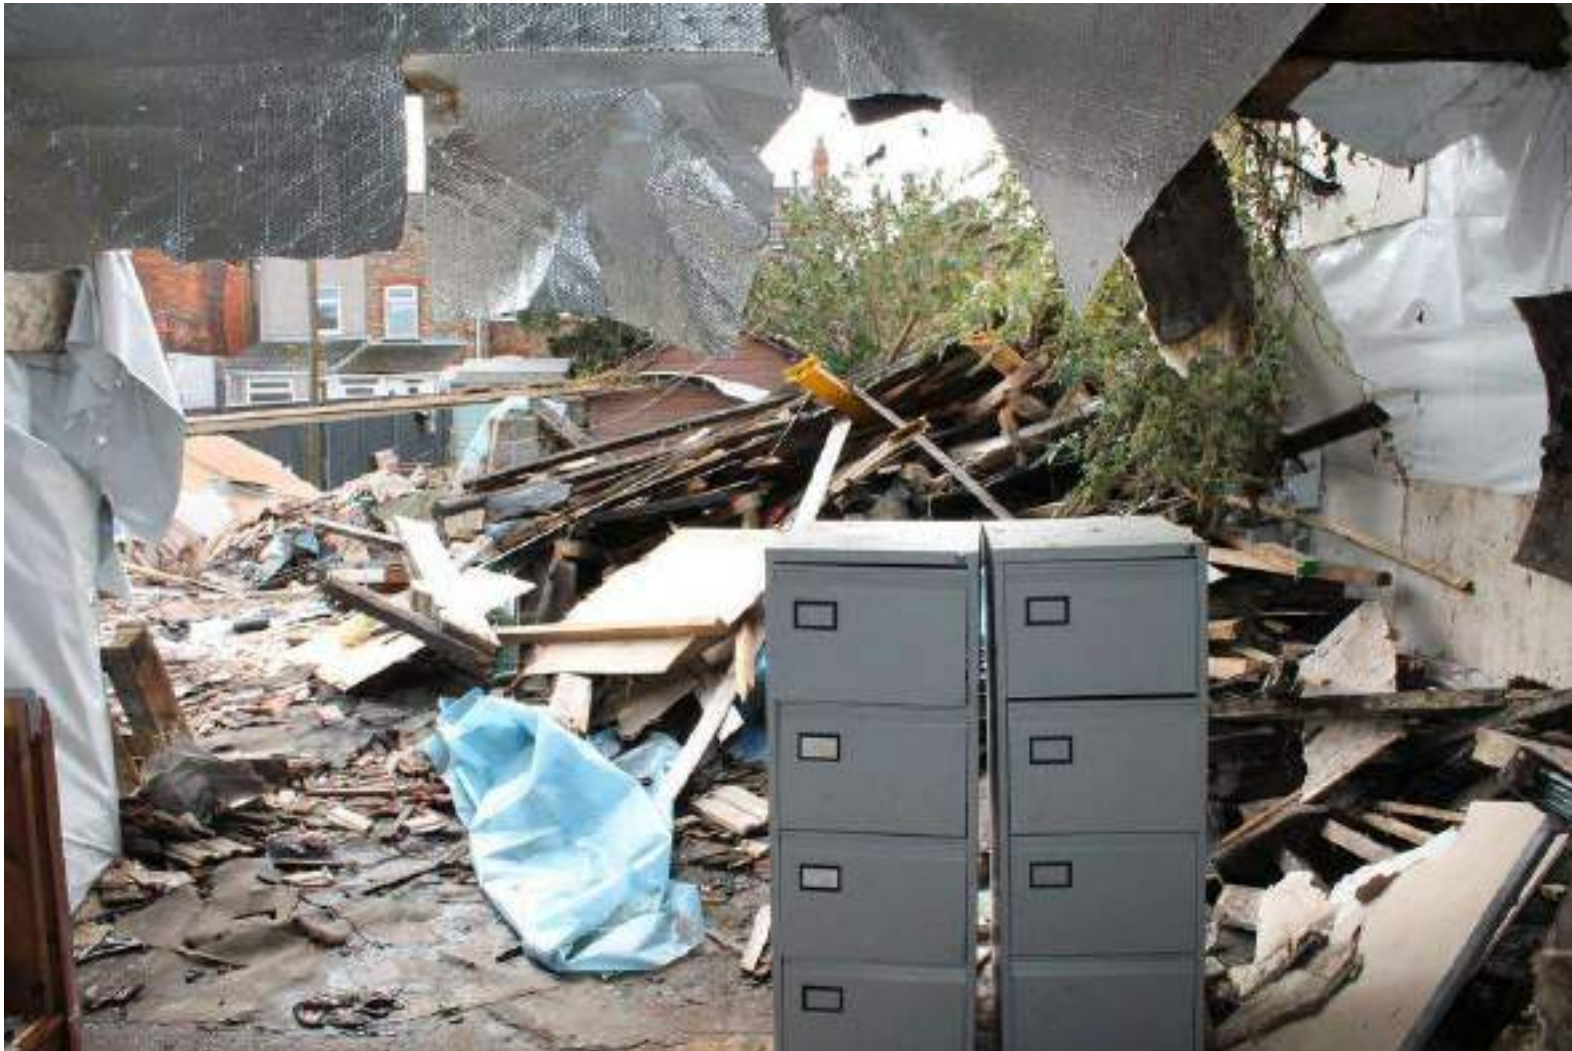
Photographs 11 and 12 show where there was open access that led from the main building into the extension. Roof B was entirely collapsed/missing and the ground beneath was littered with broken tiles and timber sections (Photographs 13-15). Straps had been secured to the east gable wall, to prevent it collapsing into the adjacent playground. Collapsed timbers had been piled up towards the west end and into the area beneath roof A.

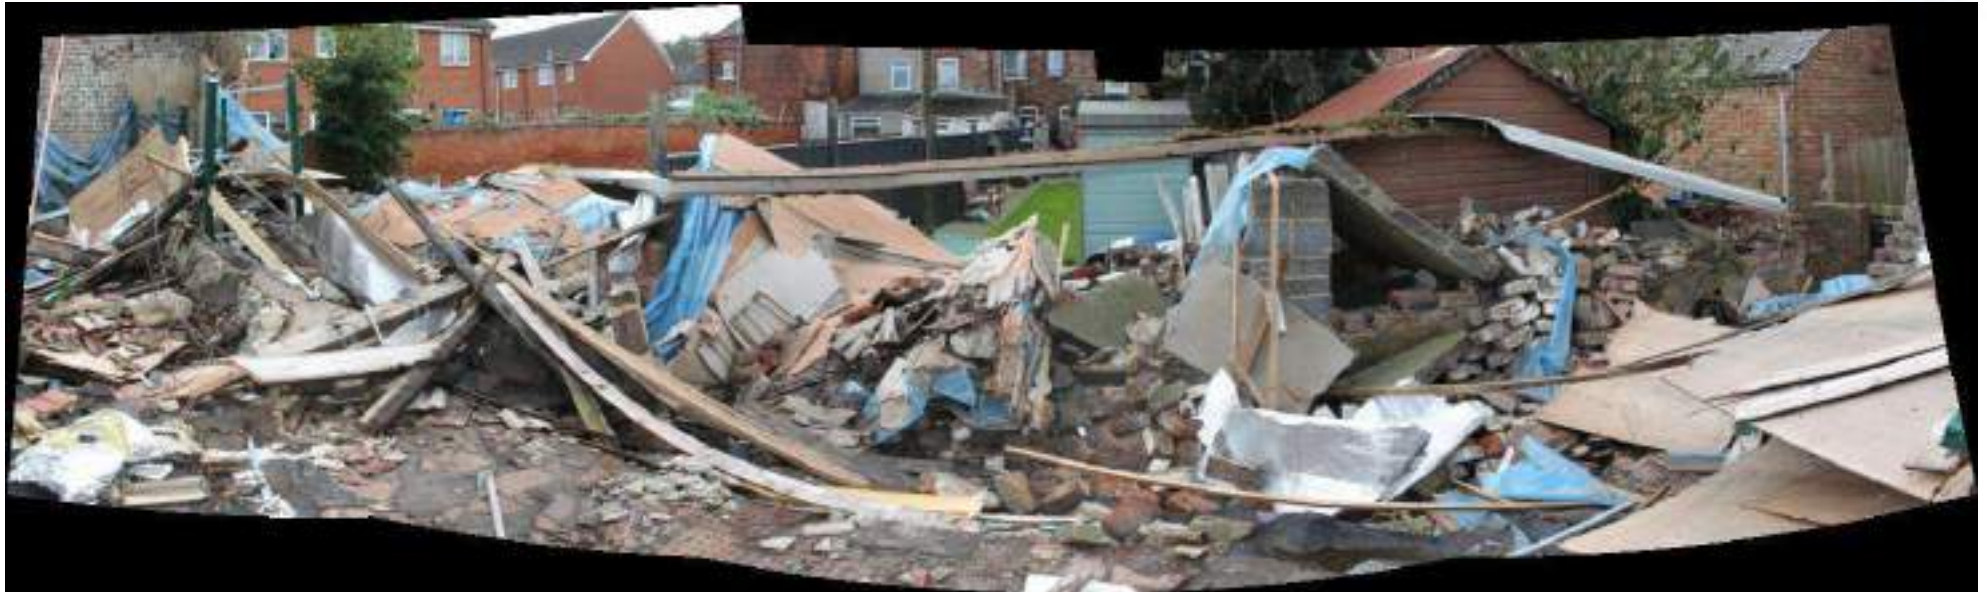
**Photograph 16**

Photograph 16 is a composite image showing where the south elevation of the extension had collapsed into the passageway that had separated the extension from the gardens of the properties on Castle Street. Masonry, guttering and sections of timber had collapsed onto fencing and into the gardens close to the passageway (Photographs 17 & 18), but the debris did not extend beyond a few metres of the passageway, and a timber shed in the garden at [REDACTED] that was relatively close to the passageway, was undamaged (Photograph 19).

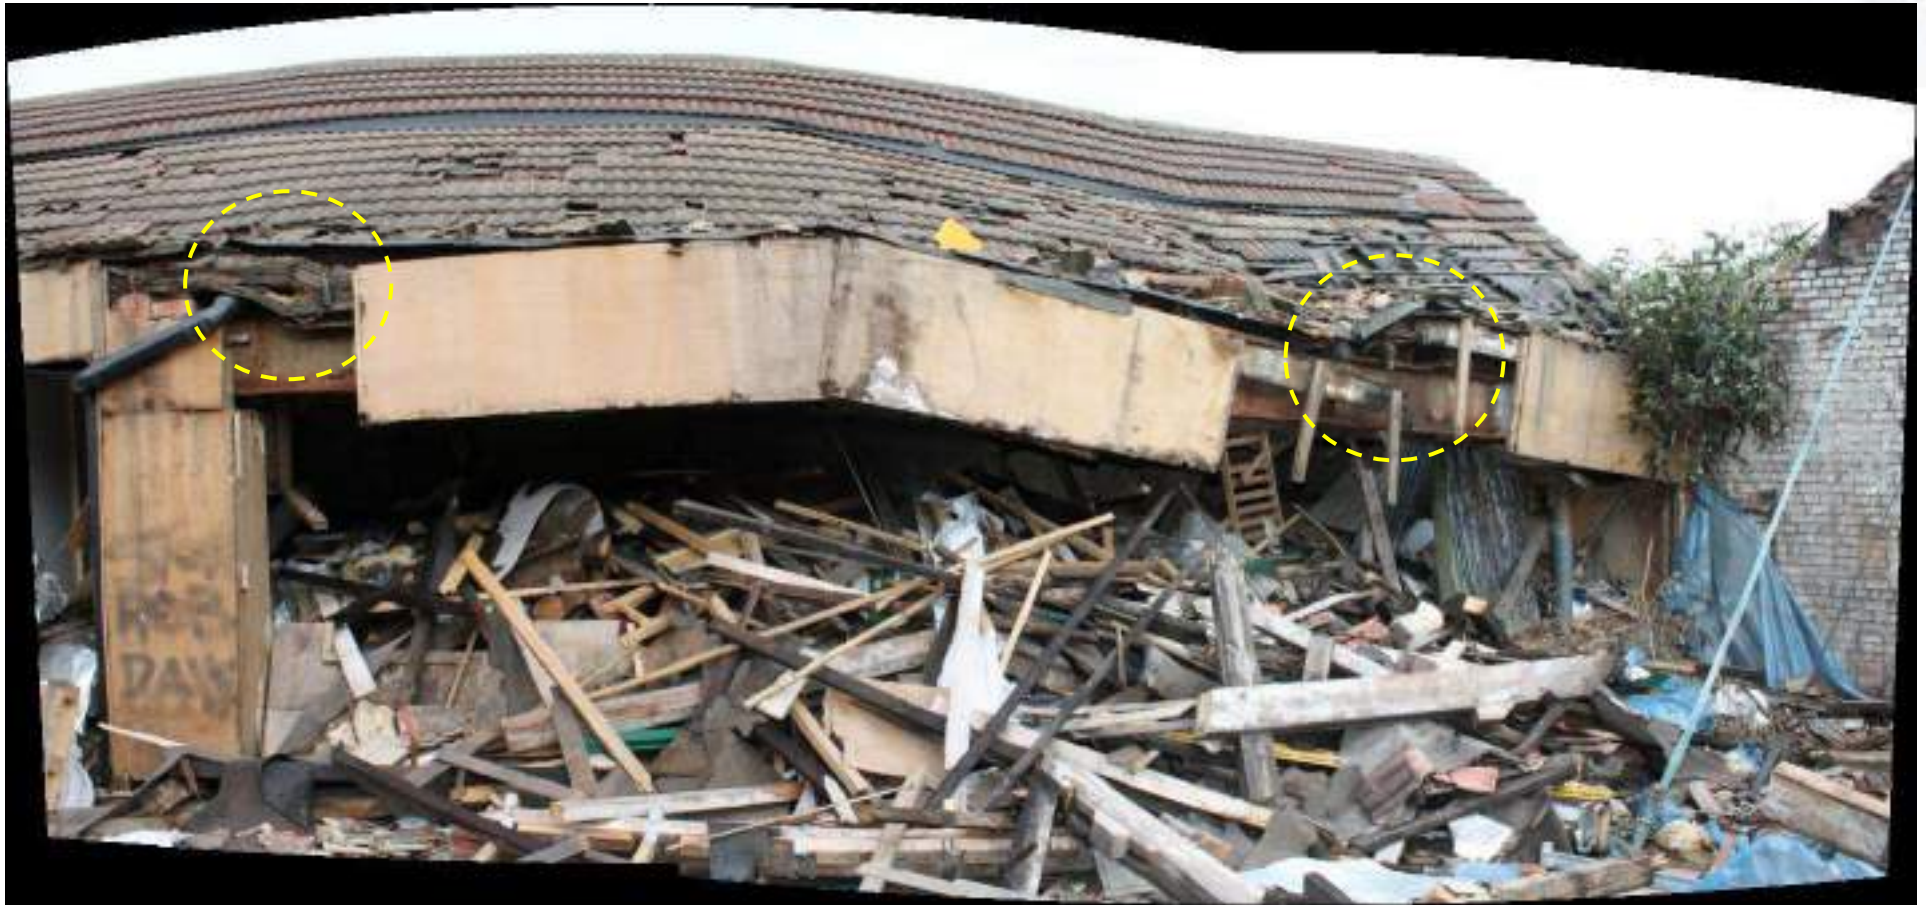
**Photograph 20**

Photograph 20 is a composite view north from the collapsed part of the extension towards roof A, showing two areas where a substantial timber member, aligned east-west, had fractured. The timber in these areas was discoloured, consistent with water damage (Photographs 21 & 22). Inspection of lengths of timber in the area of collapse revealed several sections that had been sawn through and others that had fractured (Photographs 23 & 24).

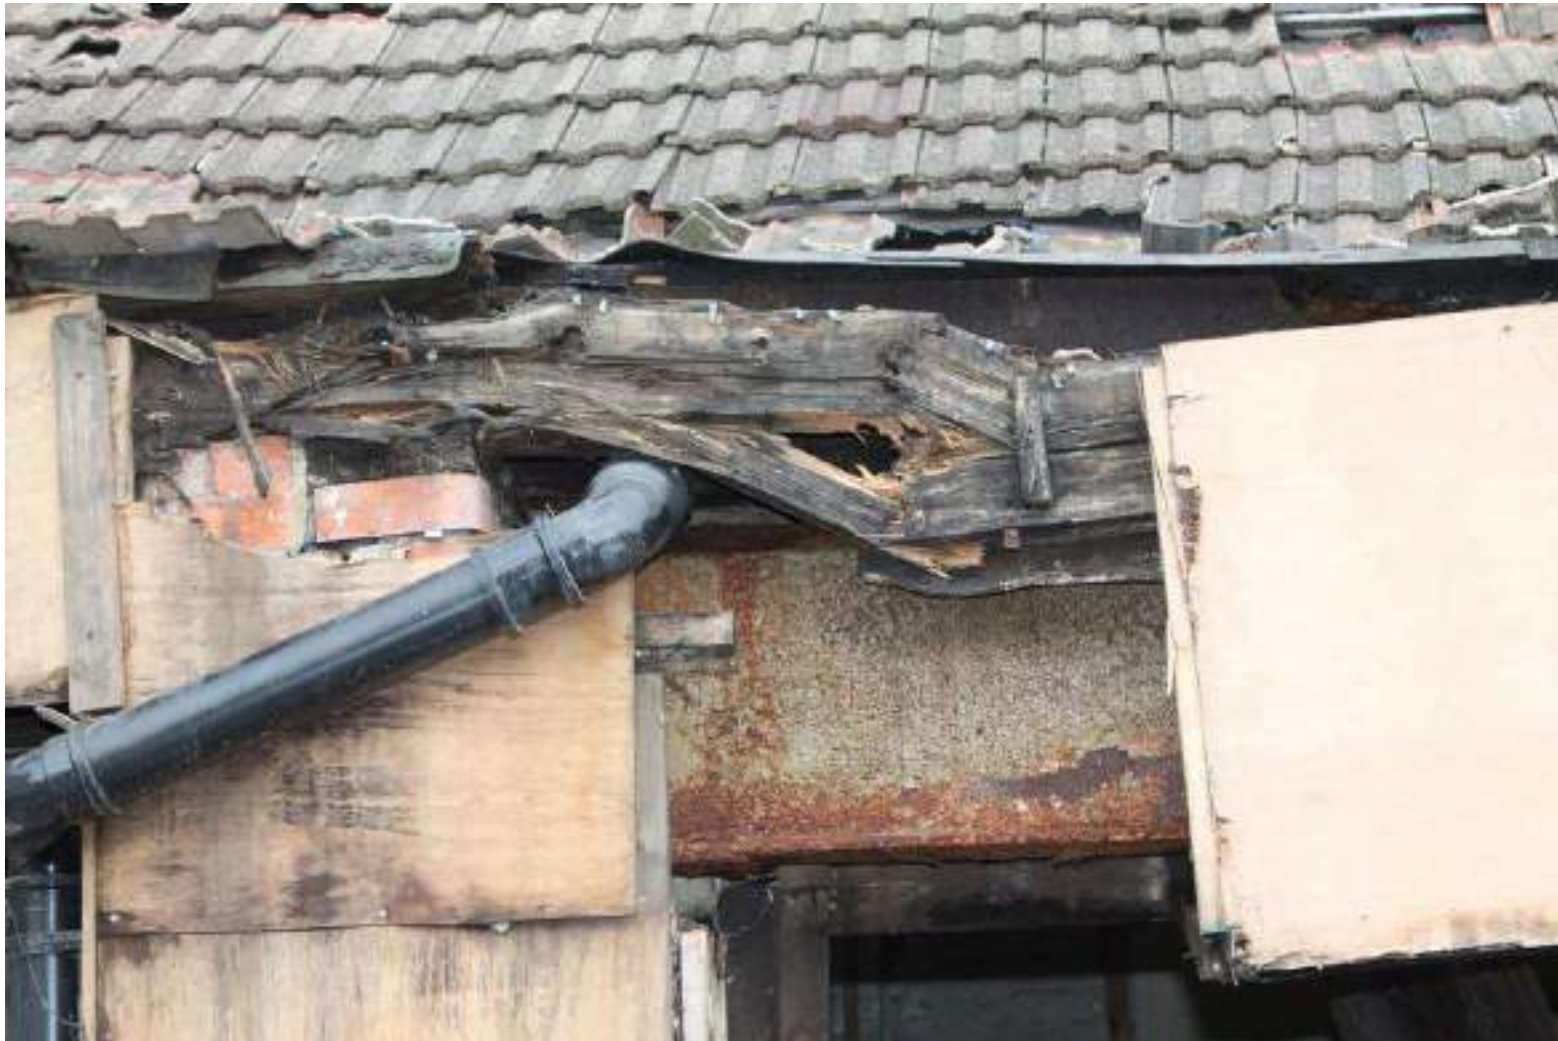
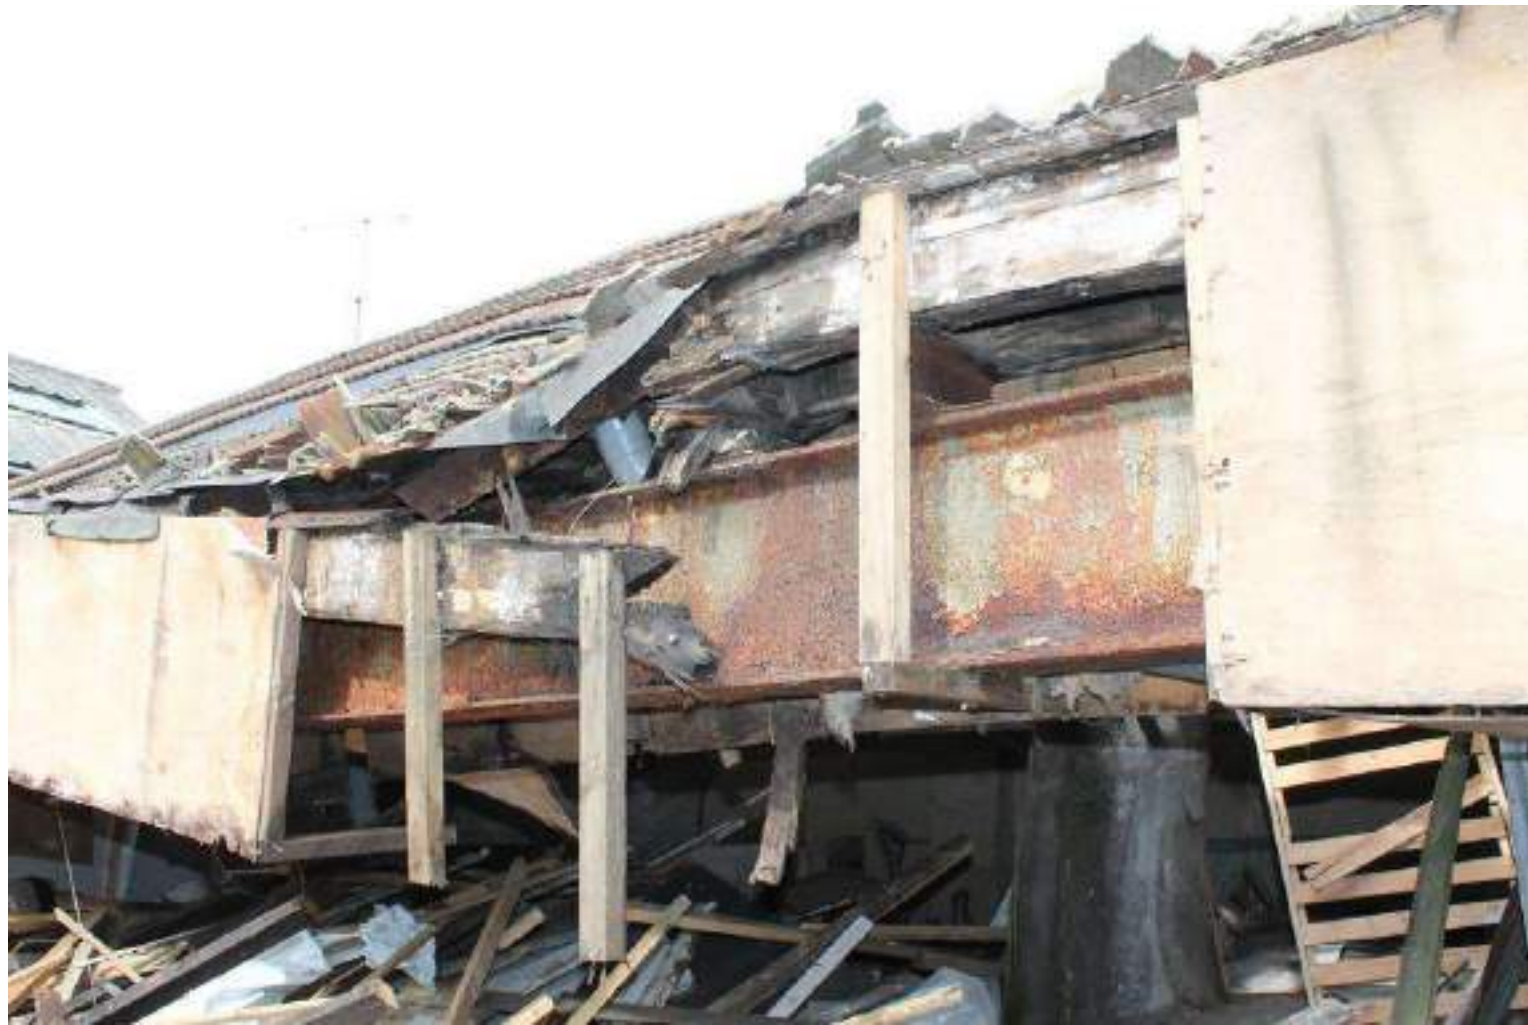
Thus, there is no evidence to suggest that the cause of the collapse was related to an explosion. Rather, collapse due to structural failure would explain the damage I observed and the description of [REDACTED]. In that regard, part of roof A had failed several years ago, there was evidence of water ingress into the main building, via the roof, and where a structural timber beam between the two roofs of the extension had fractured, discolouration of the timber looked consistent with water damage. It had also reportedly been raining in the area during the days leading up to the incident. There was clear evidence indicating that the main building and the extension had been used to cultivate cannabis, consistent with [REDACTED] account that a cannabis farm had been discovered several years ago. This had involved modifying the building by lining surfaces with reflective foil, and may also have involved installing suspended ceilings, including in the extension, thus adding additional weight to the original timber structure that supported the roof. Whilst the sawn sections of timber I saw amongst the collapsed debris may have been cut when straps were secured to the east gable wall after the incident, I cannot rule out the possibility that the roof structure had been modified/changed, and thus weakened, prior to the collapse.
