Our Ref: 713807/CLG

27 October 2023

**INSURED: ANDREAS INVESTMENTS LTD**  
**INCIDENT: BUILDING COLLAPSE AT 68A HAROLD STREET, GRIMSBY, DN32 7NQ**  
**INCIDENT DATE: 13 SEPTEMBER 2023**

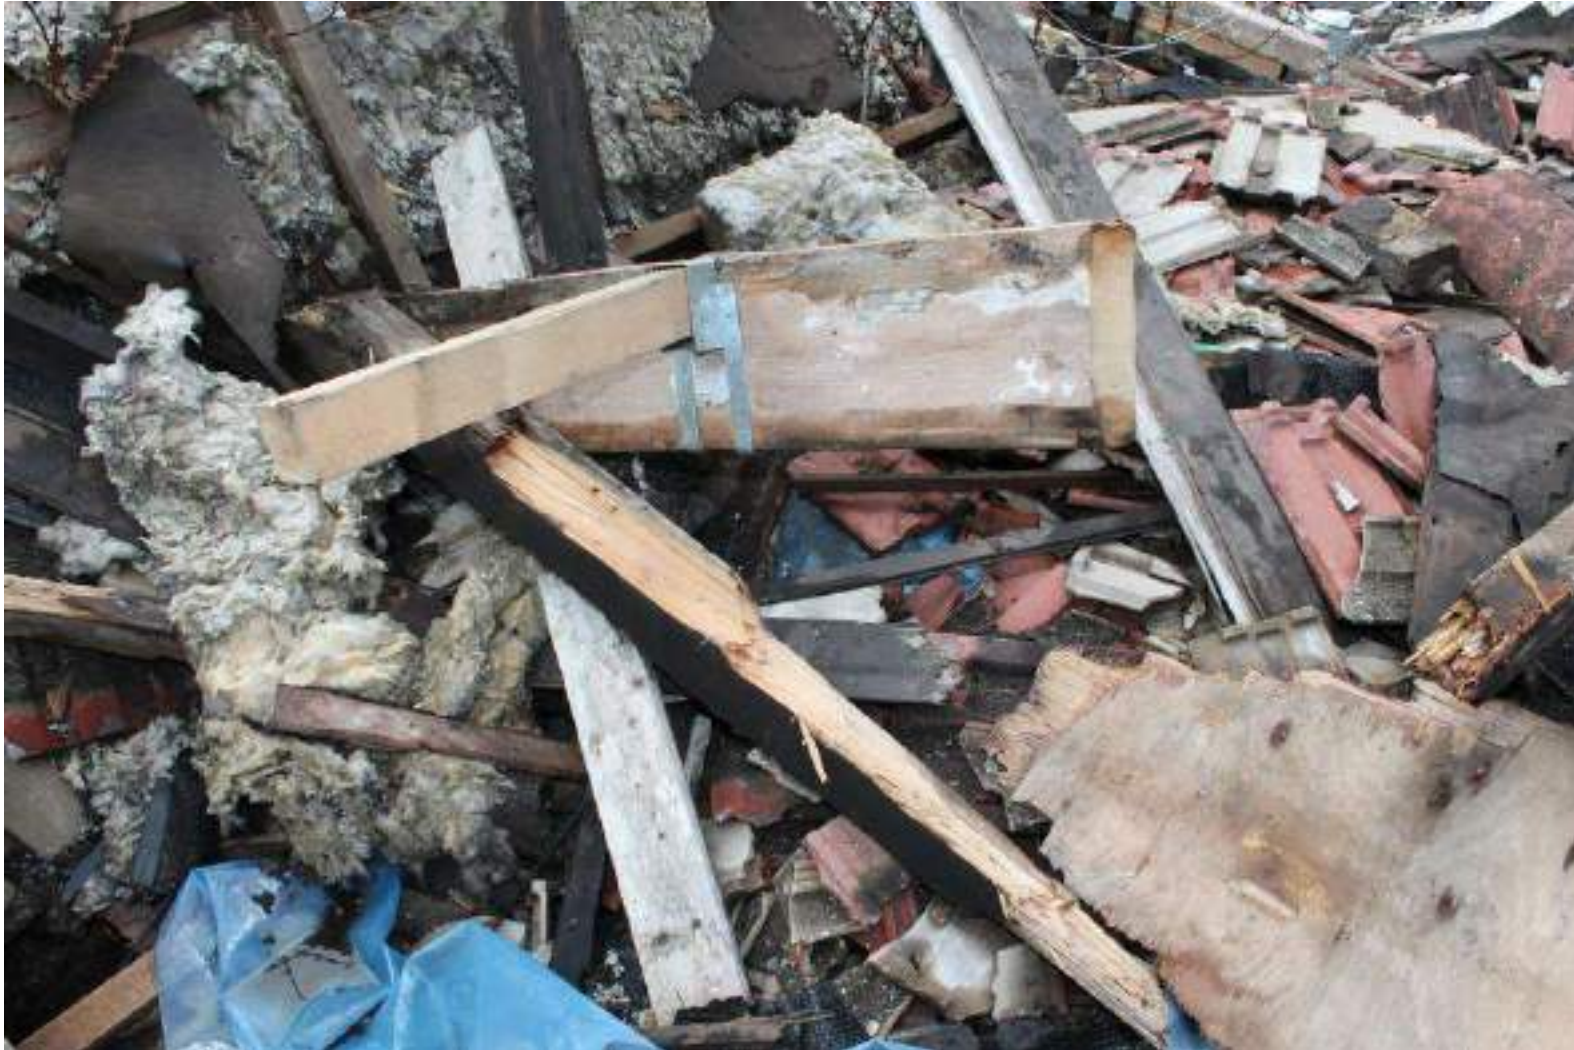
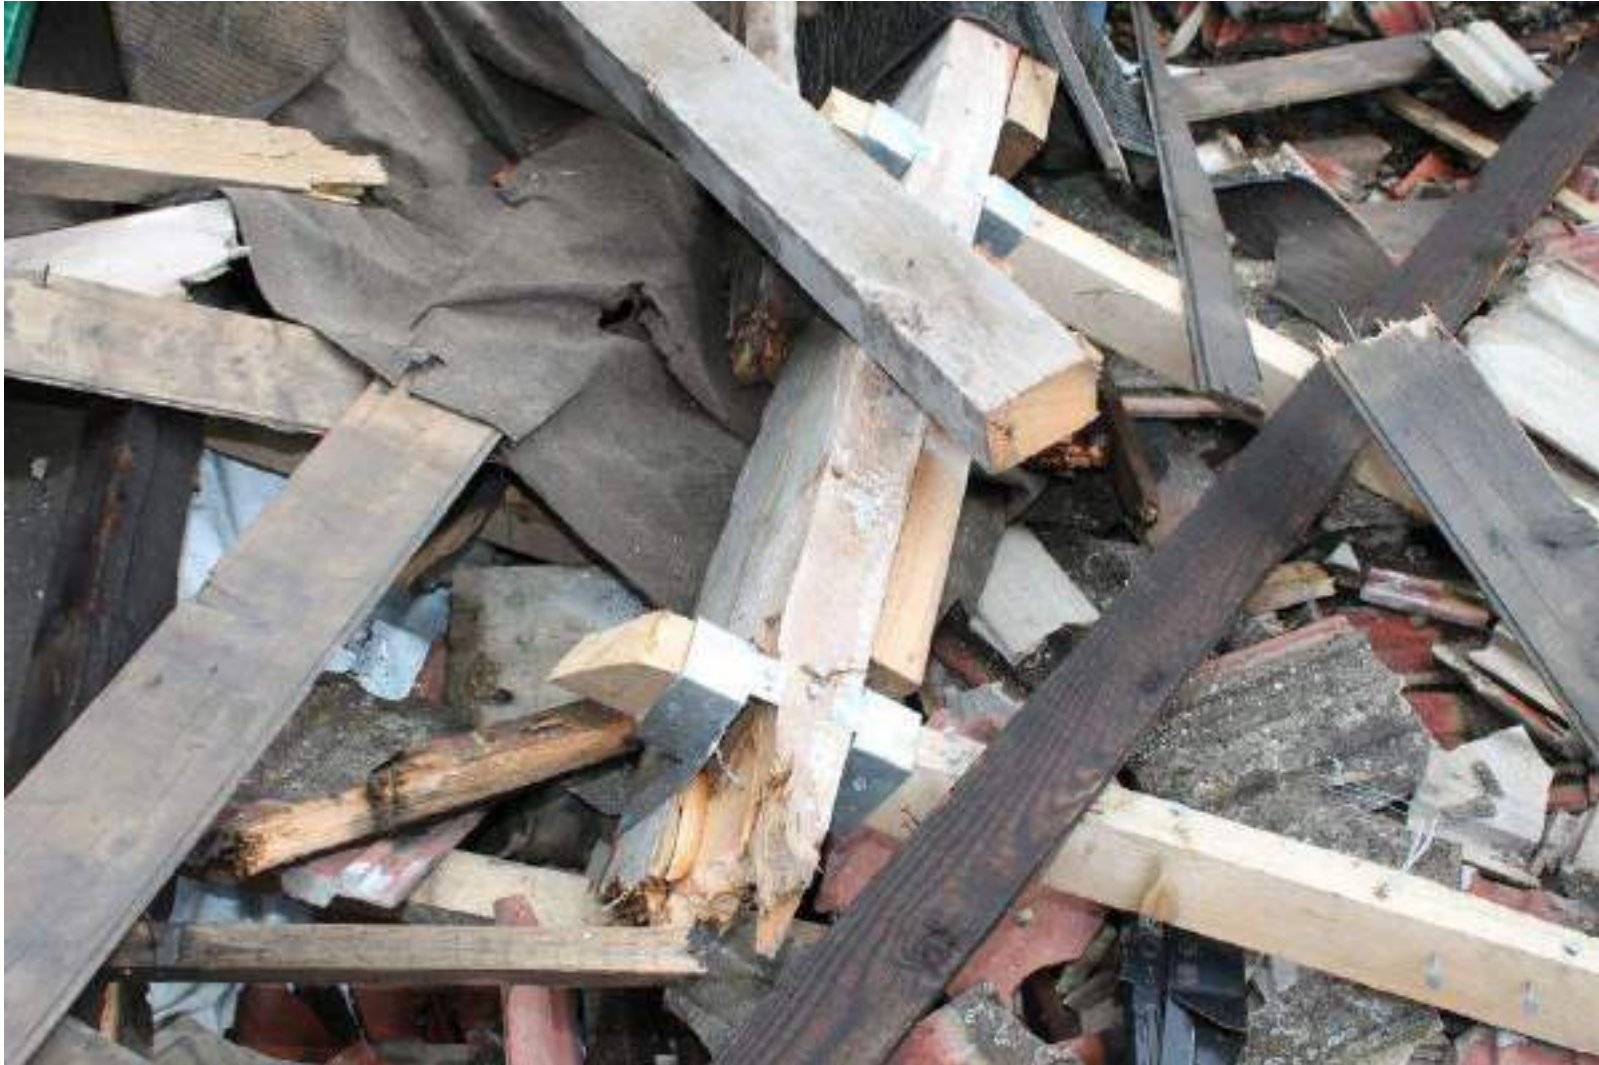
Photograph 20 is a composite view north from the collapsed part of the extension towards roof A, showing two areas where a substantial timber member, aligned east-west, had fractured. The timber in these areas was discoloured, consistent with water damage (Photographs 21 & 22). Inspection of lengths of timber in the area of collapse revealed several sections that had been sawn through and others that had fractured (Photographs 23 & 24).

Thus, there is no evidence to suggest that the cause of the collapse was related to an explosion. Rather, collapse due to structural failure would explain the damage I observed and the description of [REDACTED]. In that regard, part of roof A had failed several years ago, there was evidence of water ingress into the main building, via the roof, and where a structural timber beam between the two roofs of the extension had fractured, discolouration of the timber looked consistent with water damage. It had also reportedly been raining in the area during the days leading up to the incident. There was clear evidence indicating that the main building and the extension had been used to cultivate cannabis, consistent with [REDACTED] account that a cannabis farm had been discovered several years ago. This had involved modifying the building by lining surfaces with reflective foil, and may also have involved installing suspended ceilings, including in the extension, thus adding additional weight to the original timber structure that supported the roof. Whilst the sawn sections of timber I saw amongst the collapsed debris may have been cut when straps were secured to the east gable wall after the incident, I cannot rule out the possibility that the roof structure had been modified/changed, and thus weakened, prior to the collapse.
