Our Ref: 713807/CLG

27 October 2023

**INSURED: ANDREAS INVESTMENTS LTD**  
**INCIDENT: BUILDING COLLAPSE AT 68A HAROLD STREET, GRIMSBY, DN32 7NQ**  
**INCIDENT DATE: 13 SEPTEMBER 2023**

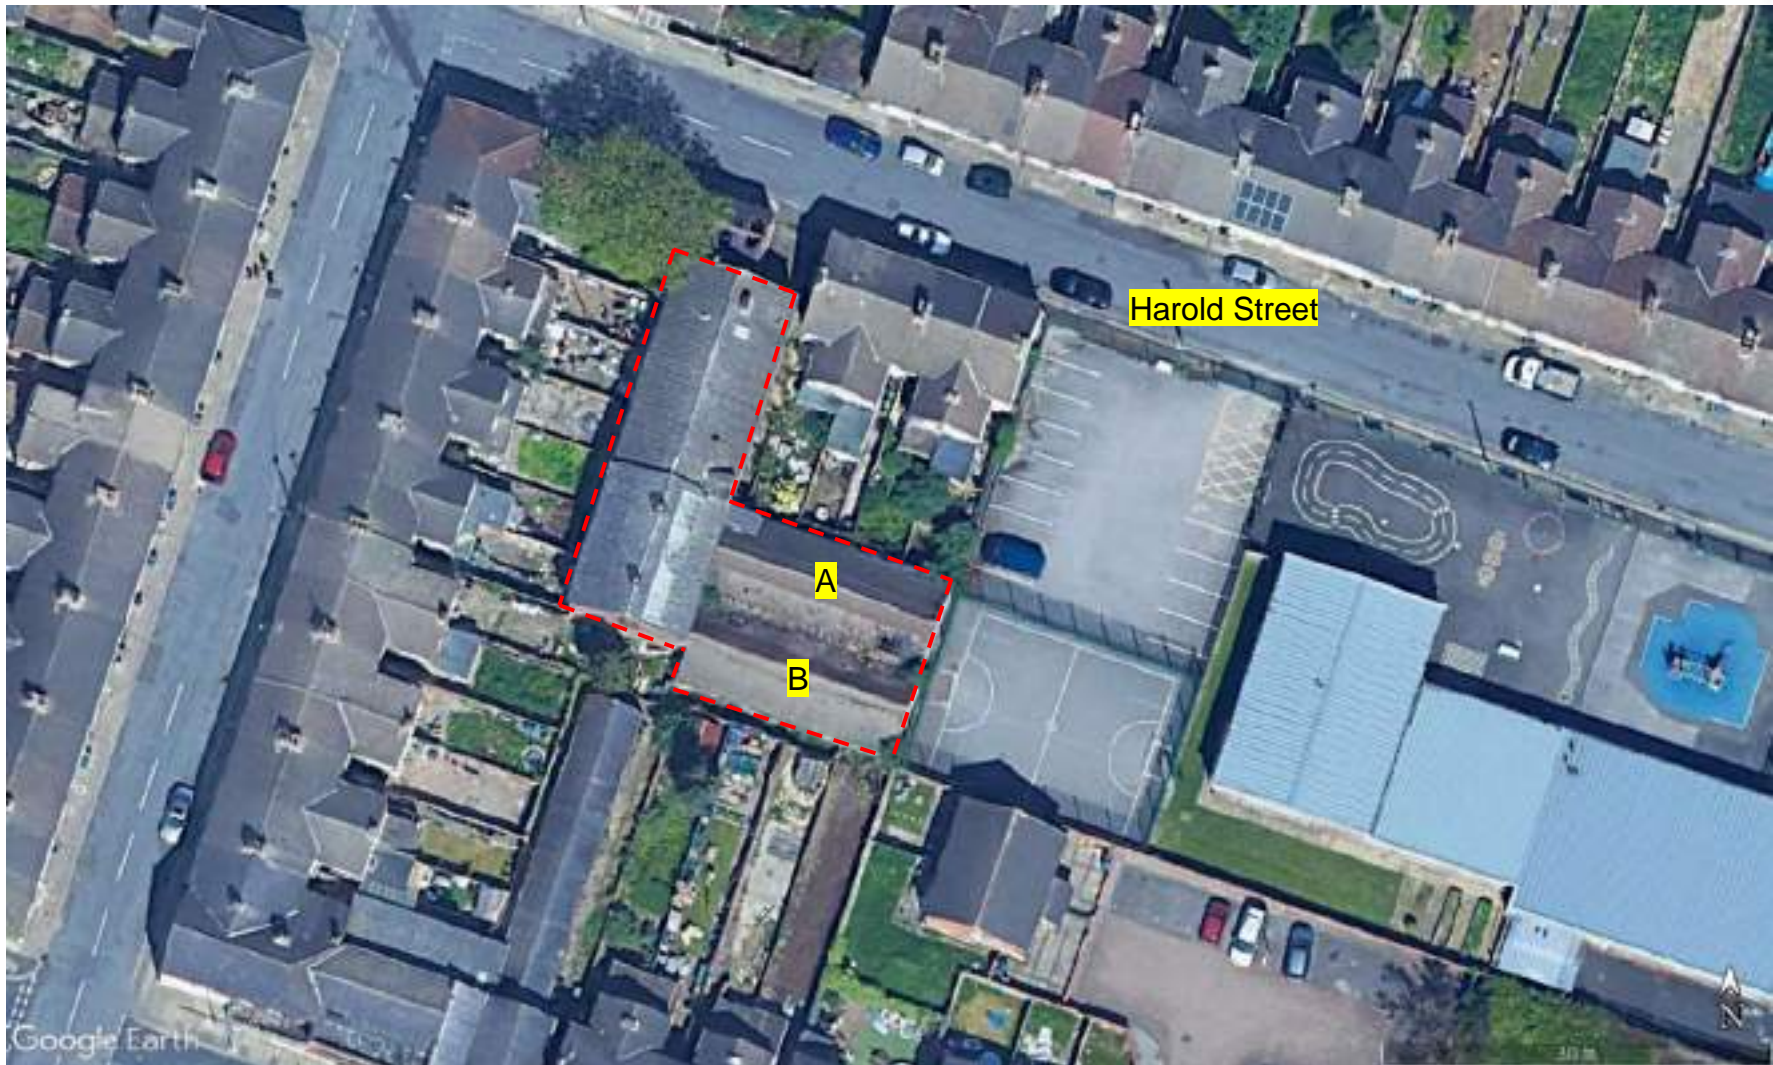
**Figure 1**

Figure 1 is a Google Earth image (dated April 2023) showing the location of the incident address relevant to neighbouring properties. It is an L-shaped industrial building (highlighted in red), with a main two-storey section, aligned north-south, accessible from Harold Street to the north, and a single-storey section, aligned east-west, attached at the south-east end. This part of the building was of traditional brick construction with a twin-pitched, timber-framed, tiled roof. For the purposes of this report, I have denoted the single-storey section as the “extension”, and its north and south roof pitches as A and B, respectively. The south elevation of the extension (highlighted in yellow in Figure 2) faced the back gardens of four properties on Castle Street to the south. The east gable walls of the extension were adjacent to a school playground.

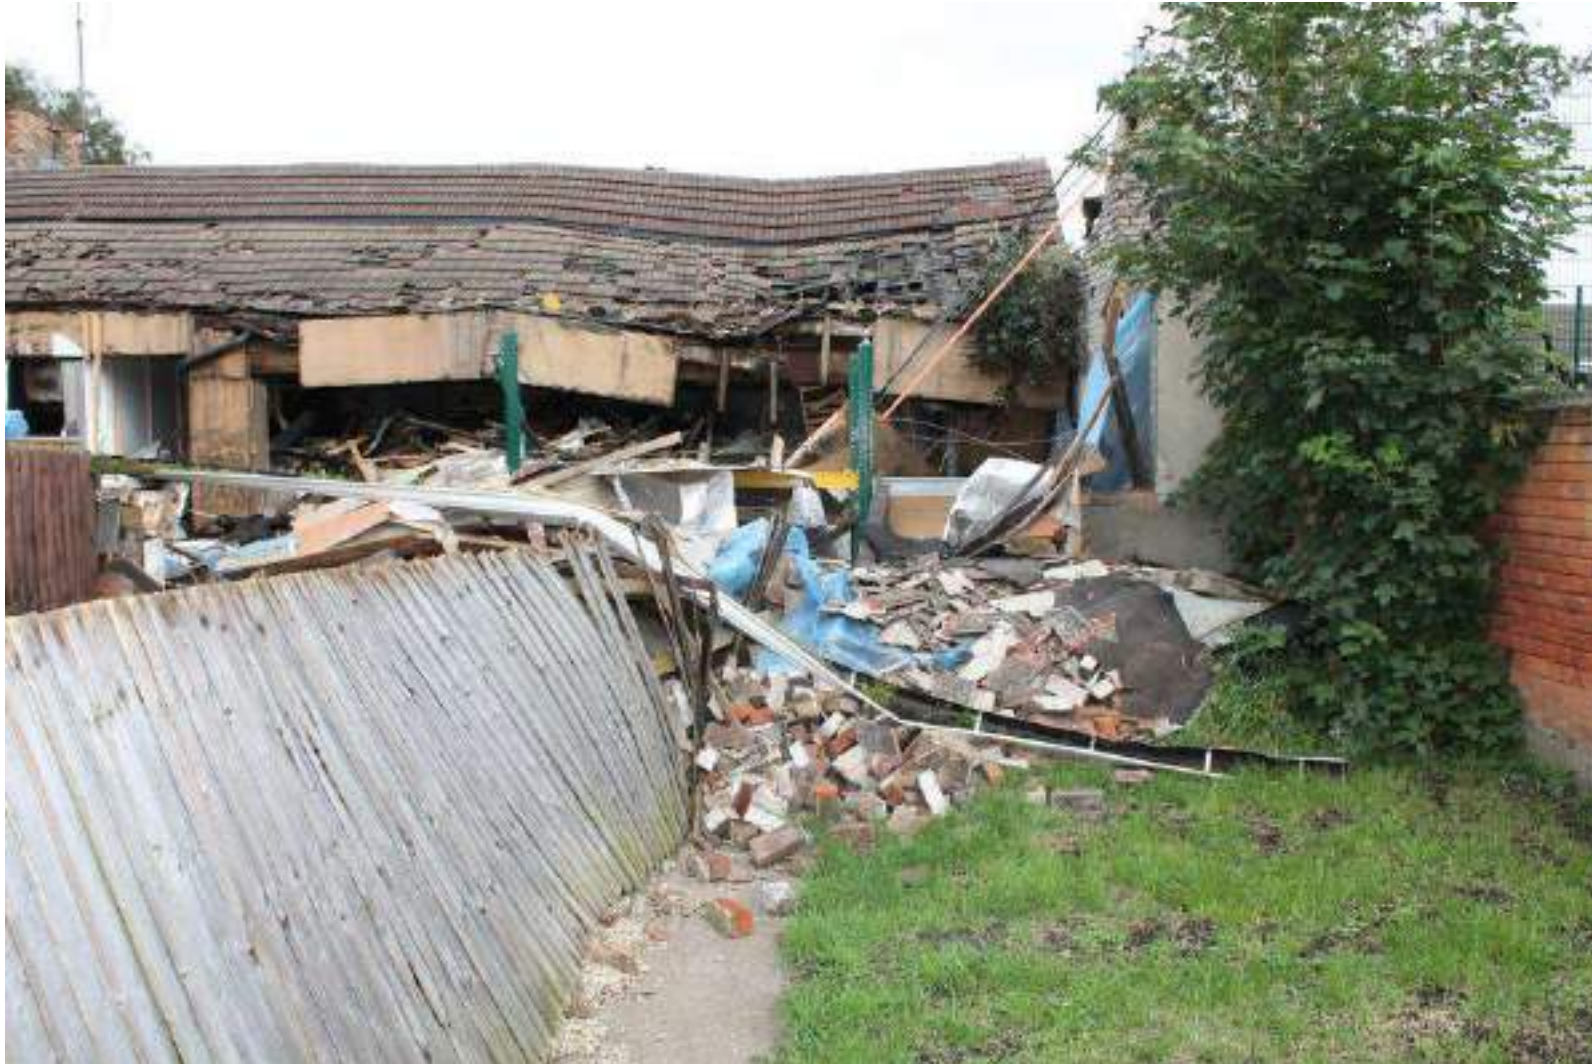
**Photograph 17**

Photograph 16 is a composite image showing where the south elevation of the extension had collapsed into the passageway that had separated the extension from the gardens of the properties on Castle Street. Masonry, guttering and sections of timber had collapsed onto fencing and into the gardens close to the passageway (Photographs 17 & 18), but the debris did not extend beyond a few metres of the passageway, and a timber shed in the garden at [REDACTED] that was relatively close to the passageway, was undamaged (Photograph 19).
